The Independent Fact Group

Subject: Incontrovertible and final proof that the visor was detached from the ship after the sinking of MV Estonia.

Type: Analysis
By: The Independent Fact Group
www.factgroup.uk

Date: 2020-12-24

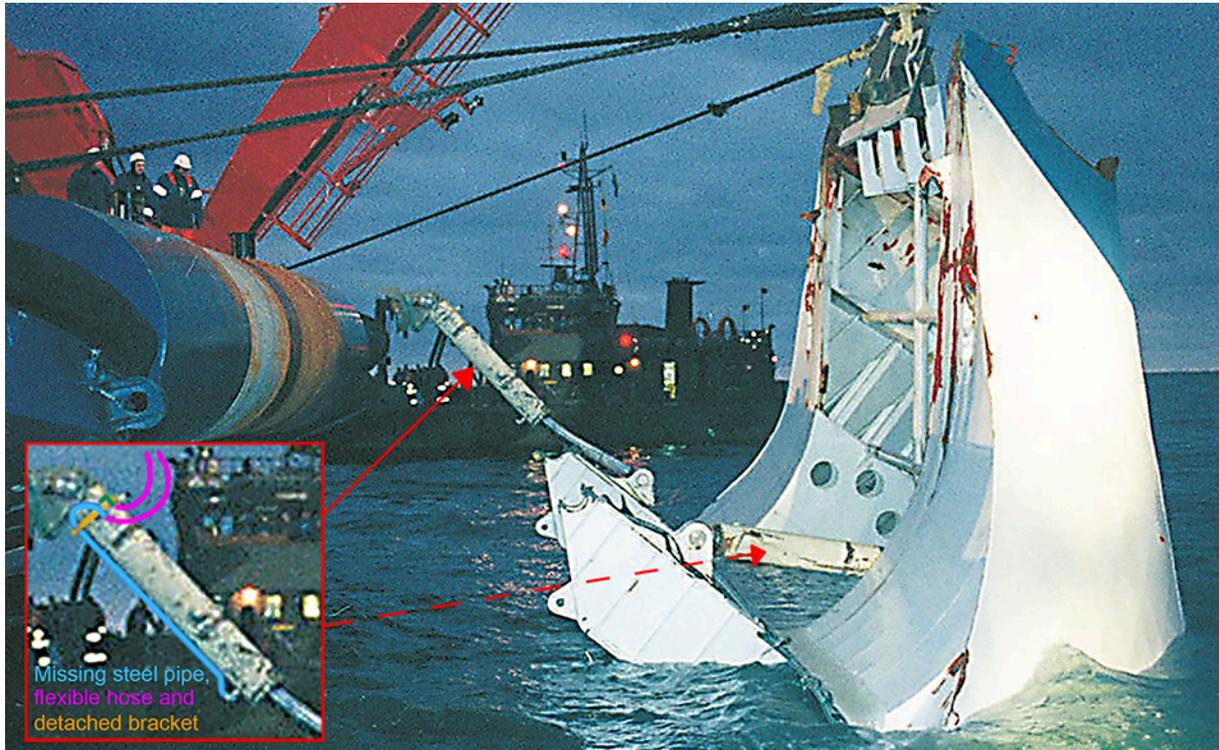
When the visor was brought to the surface no parts of the actuator hosing was to be found. The inlet 90 degree attachment pipe made in steel with its attachment sealing nut was found with no damage. The steel pipe was missing. No flexible hoses or remains of them were found. The complete return steel pipe was detached all way to the corresponding 90 degree attachment pipe in the other upper end of the actuator. **This is incontrovertible.**

Picture 6. The missing hoses and steel pipe and the bracket with clam have been indicated with colored lines (close up), all in reference to Picture 1 and in detail Picture 3.

The clam for holding the fixed steel pipe had been opened and the pipe had been removed. The clam was an integrated part of the bracket and surprisingly, the bracket and clam were back in place, but now without the steel pipe. The two screws in the clam for fixation of the steel pipe to the actuator was found intact and in place.

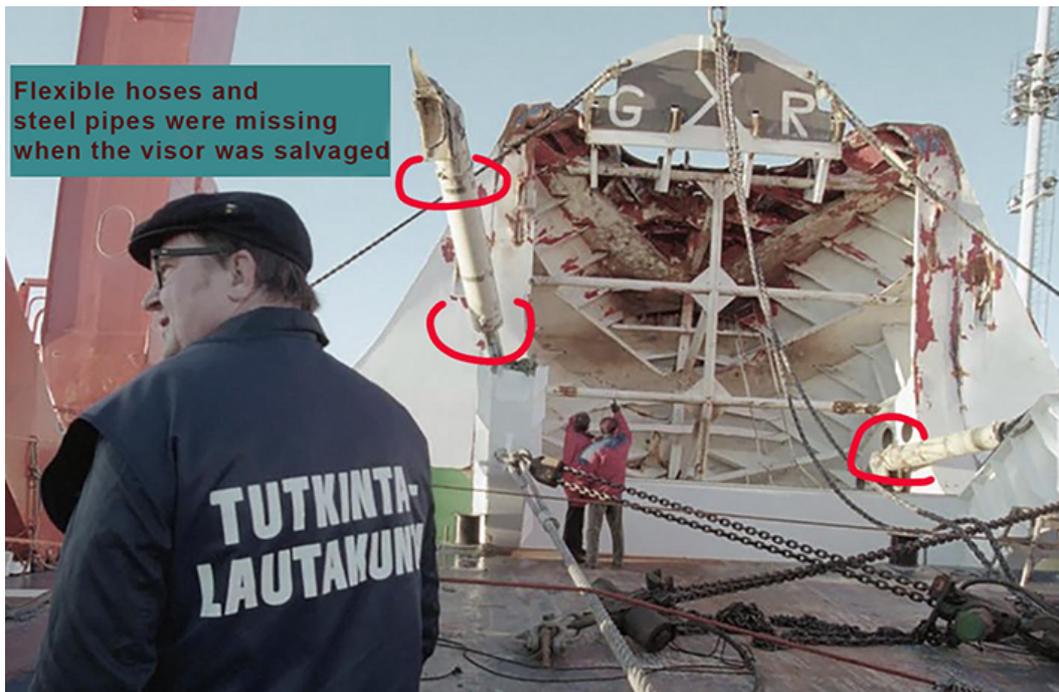
From picture 6, 7 and 8 it is absolutely clear that the hoses and pipes were missing when the visor was salvaged to the surface.

Picture 7. The missing hoses and pipes should have been within the red marking. The photos in Picture 7 and 8 were shot when the visor was salvaged to the surface and had been secured.

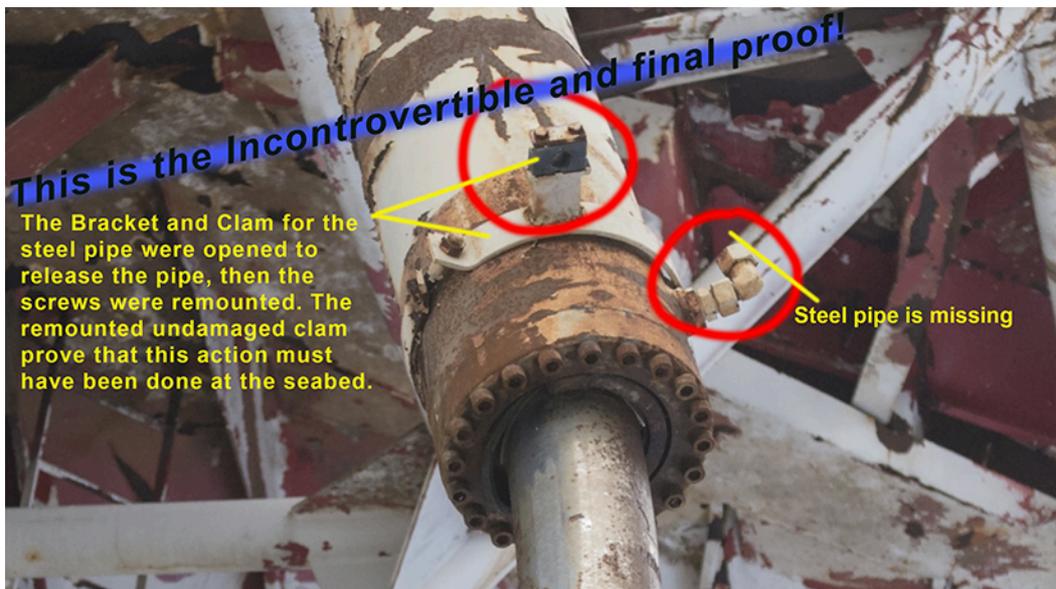
Picture 8. This is a close up of the starboard actuator upper end (close to P 2 in picture 1). It proves that the bracket and clam to the left had been opened to release the steel pipe and that the clam was remounted with it's two screws. To the right the undamaged attachment sealing nut (90 degree steel pipe) was left with the nut still in place and found without the hydraulic pipe (or it's remains) originally attached to it. In detail, see Picture 3.

Both the steel pipe and flexible hydraulic hoses were missing. The bracket and clam for the steel pipe and the 90 degree attachment pipe made in steel were found intact. It is not possible that the hoses and pipe disconnected from the actuator and fell off by themselves. The hoses should have been in place when the visor “fell off” and the remains of the flexible hoses had been found still attached to the actuators. The steel pipe should also have been in place and found attached to the actuators. This was not the case. **This is incontrovertible.**

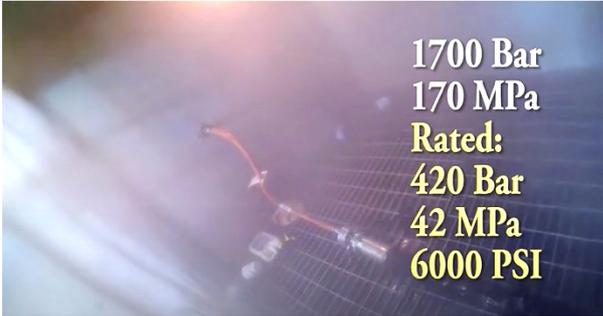
Picture 11. Burst, exploding at 1700 bar.

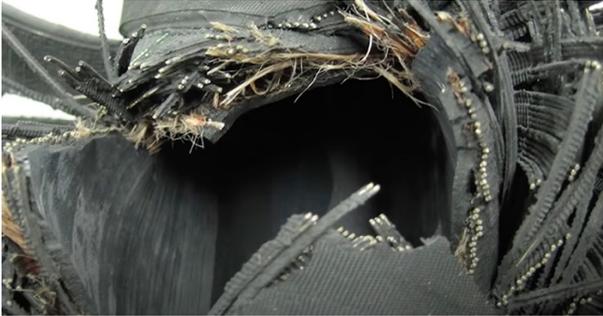
Picture 12. Damage.

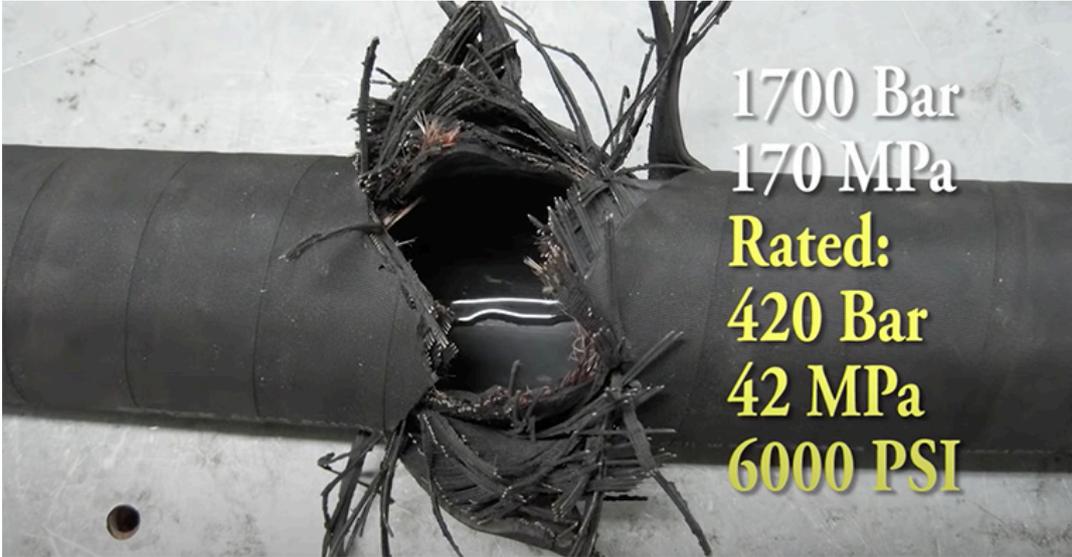
Picture 13. Damage, total destruction. If the hose had been ripped to breakage the damage had been similar.

In picture 9 – 13 the result of a burst hydraulic flexible and high pressure hose is seen. As the hydraulic hose is weaker than the steel pipe it should have been ripped and broken similar to the burst of the hose in picture 13. Alternatively, the 90 degree attachment pipe made in steel with its attachment sealing nut had been broken due to the ripping effect. It was not.

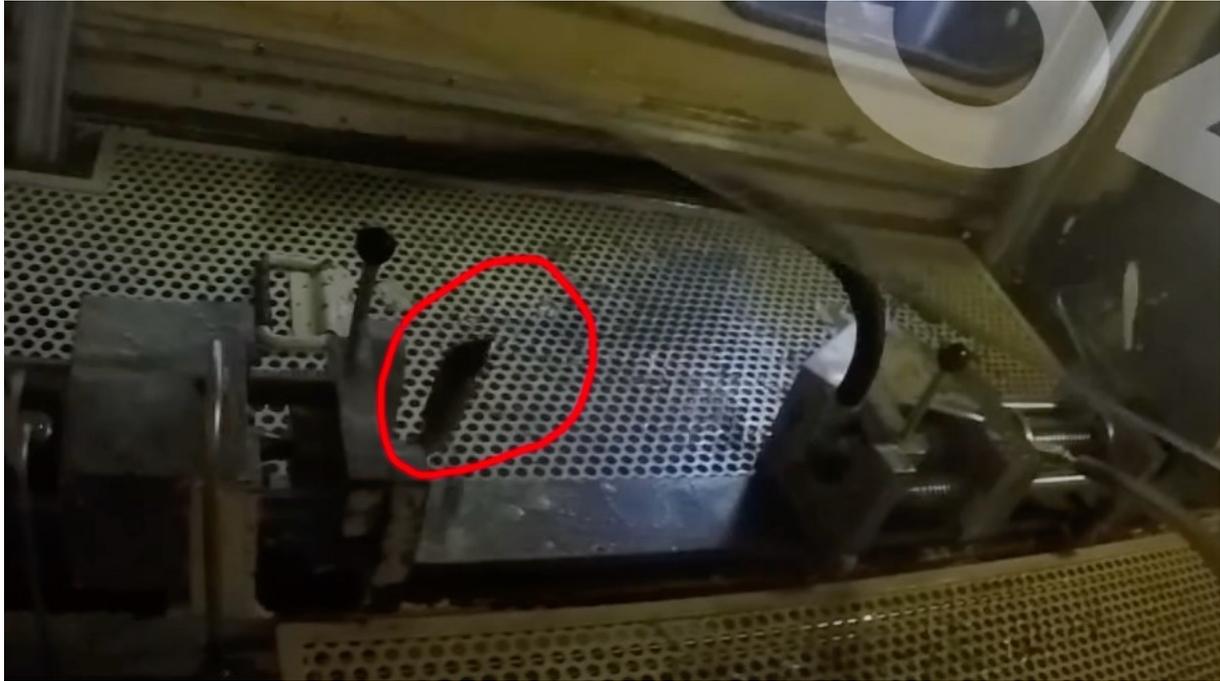
Picture 19. *Remains of the hose after burst.*

As the pressure needed to destroy the actuator seals must be at least 1400 bar we conclude that the flexible hosing's rated between 275 to 350 bar would have burst before the piston rod seals had been damaged. However, the flexible hoses and the steel pipe were missing and the screws in the bracket and clam were remounted, that is the crucial and incontrovertible key information in this report.

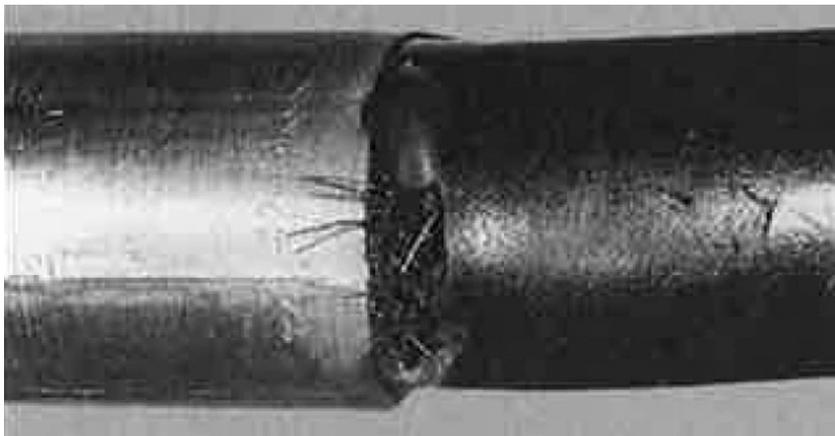
Picture 20. *Example of flexible oil hose broken due to traction.*

This example shows a hose burst at the fitting, with broken wires at the last shell grip, or at the end of the nipple where it was fixed to the steel attachment pipe. The hose was moving within - or ripped - at the fitting. This excessive movement should have been the result if the visor “fell forward” according the claim in the JAIC scenario.
