**Subject:** Lies and truths about the salvage of MV Estonia's MOB rescue boat, and further on, The Independent Factgroup present their final investigation report regarding the MOB boat.

**Type:** Analysis  
**By:** The Independent Fact Group  
[www.factgroup.uk](http://www.factgroup.uk)

**Status:** Proved  
**Date:** 2022-04-11  
**Version:** Report-English

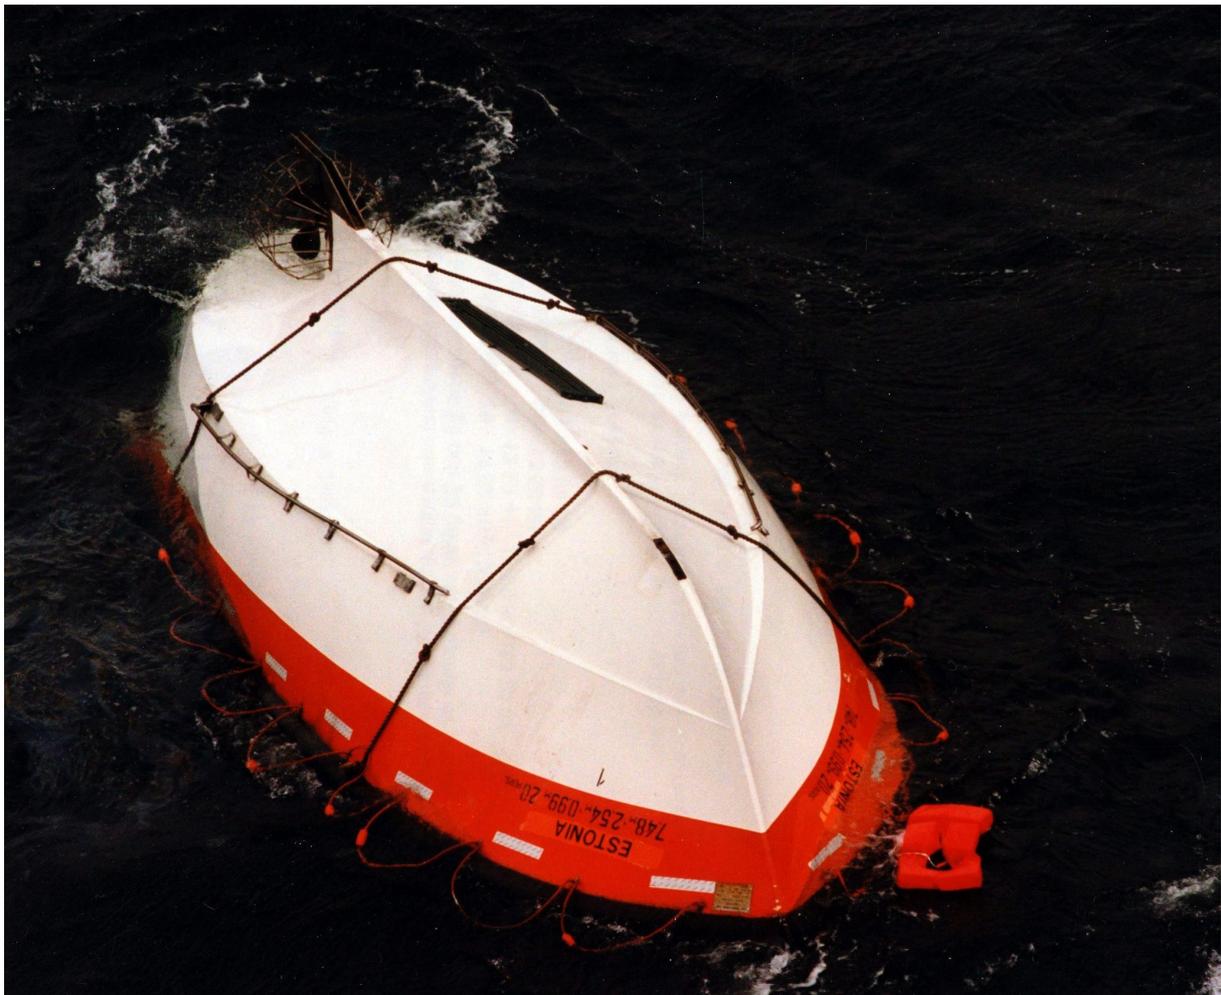
The MOB boat was floating upside down and had drifted 10,6 nautical miles with an average drifting speed of 1,25 knots. It had been drifting east with other lifeboats, rafts, and debris.

Picture 2. The MOB boat (number 1) photographed in the morning the 28<sup>th</sup> of September 1994. Photo: Leif R Jansson.

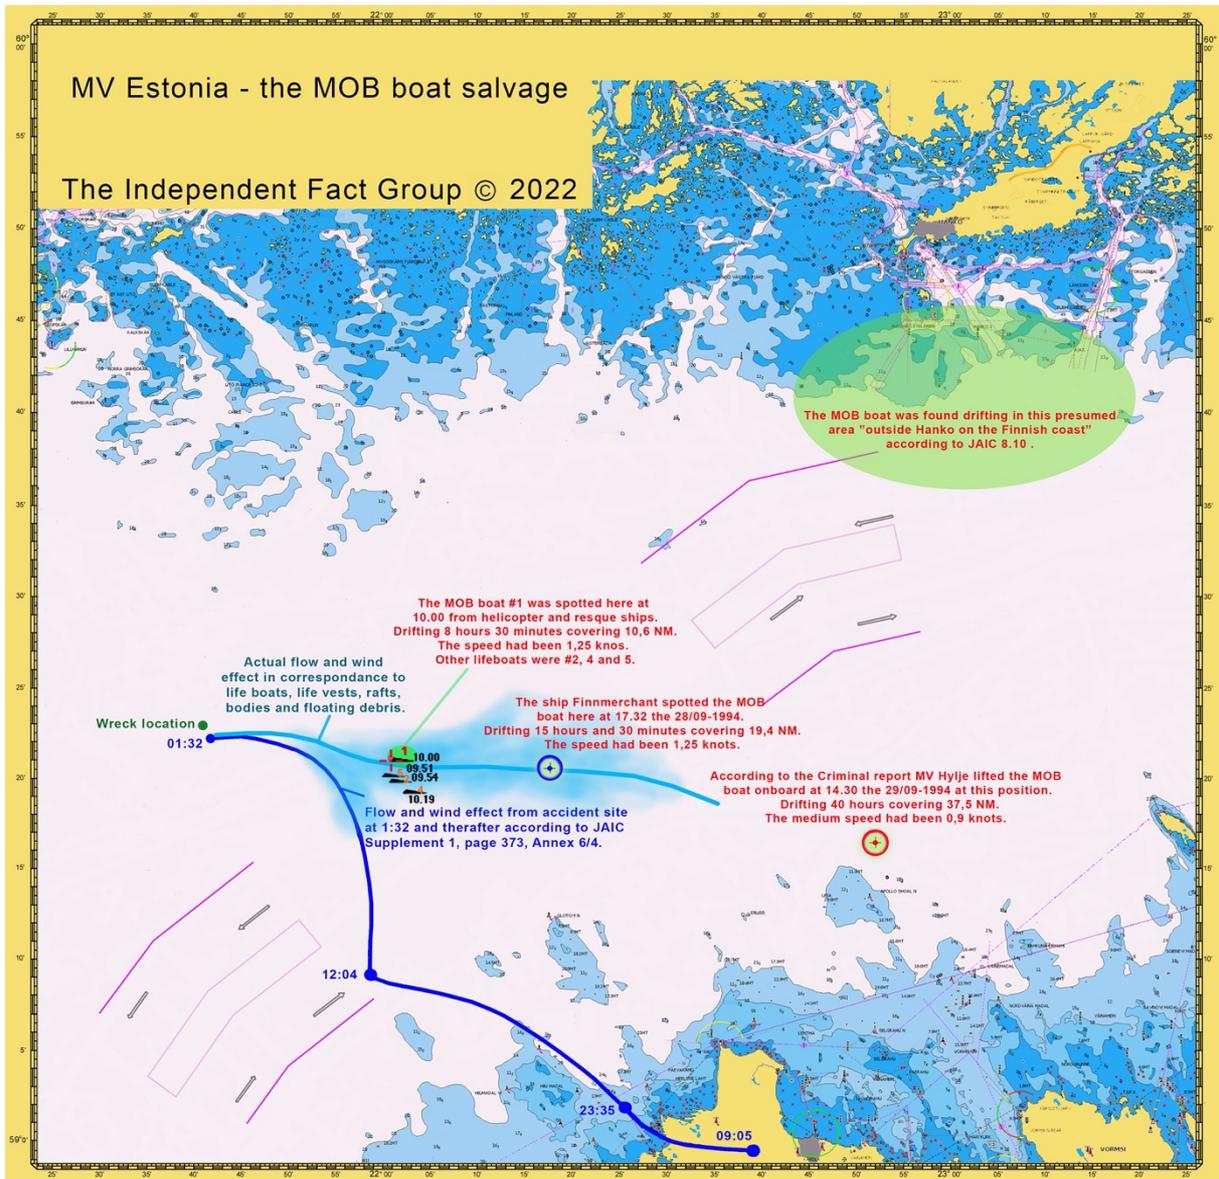
The map below (picture 3) shows how the MOB boat drifted, where it was spotted, and where it was salvaged, according to information from the Finnish police. We also show the actual course that the objects and debris from MV Estonia followed.

Picture 3. The MOB boat drifting scenario.

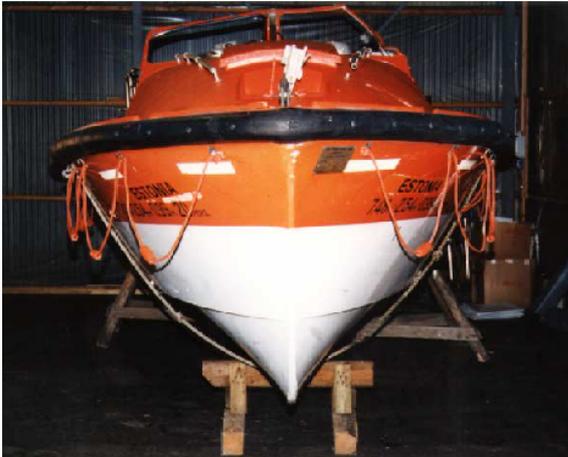
*National Bureau of Investigation picture # 1*

*M/V Hylje brought the M/V Estonia's MOB boat to Hanko on 29.9.1994. During the investigations it has become clear that the MOB boat is in good condition, without hull damages, picture # 1.*

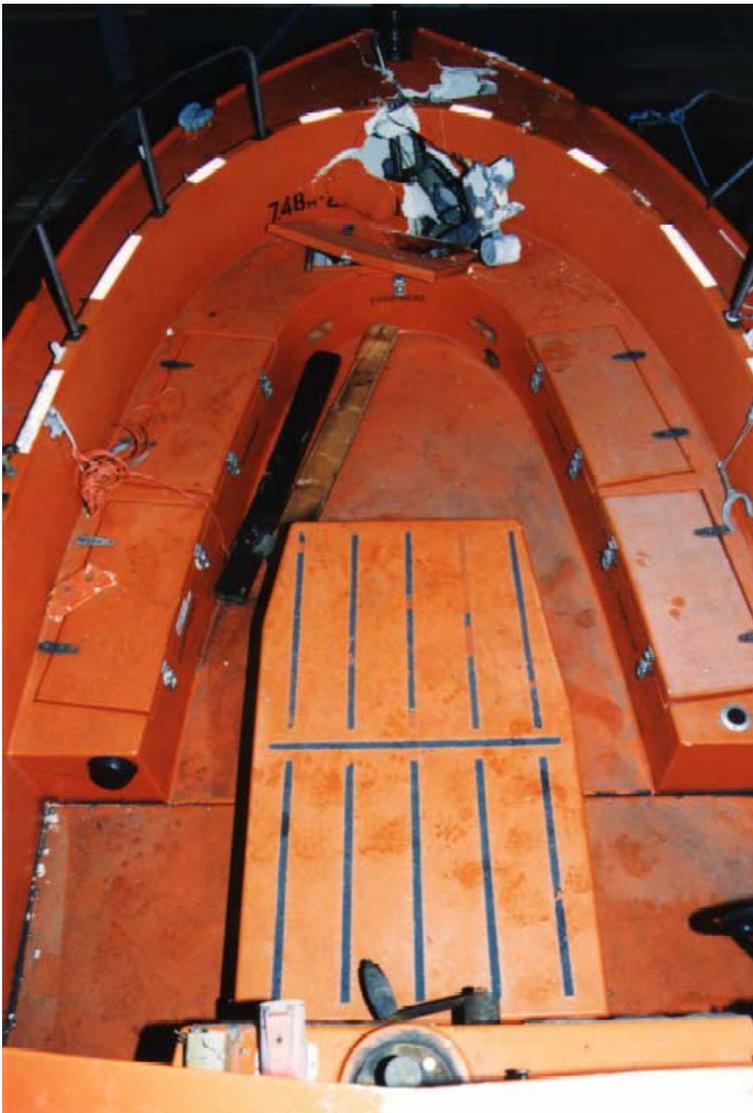
*National Bureau of Investigation picture # 3*

*The aft hook release fastening irons have torn the deck structure. Based on the damages at both hook release arrangements we find reason to assume that the said MOB boat has not been released from its hooks under controlled circumstances, but it has torn loose from its hooks in the same manner as the other lifeboats, picture # 3.*

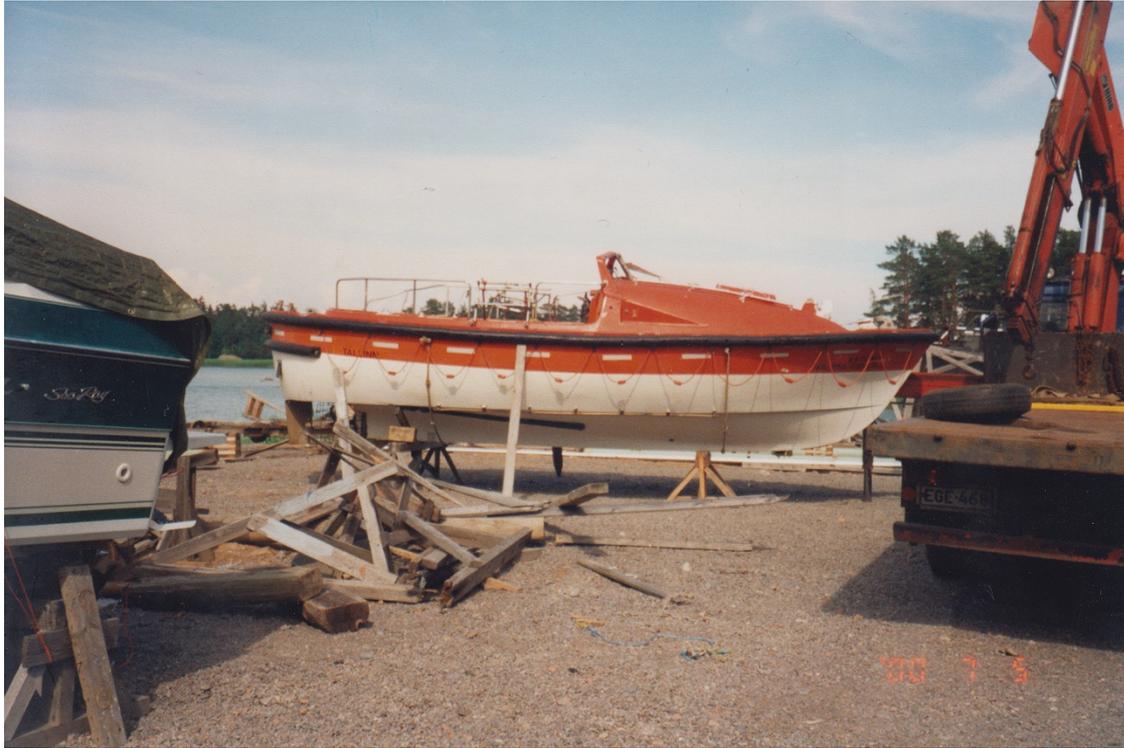
Damage report picture 2. *The MOB boat at the Hanko free camp 2000.07.05. Photo: Lars Andersson.*

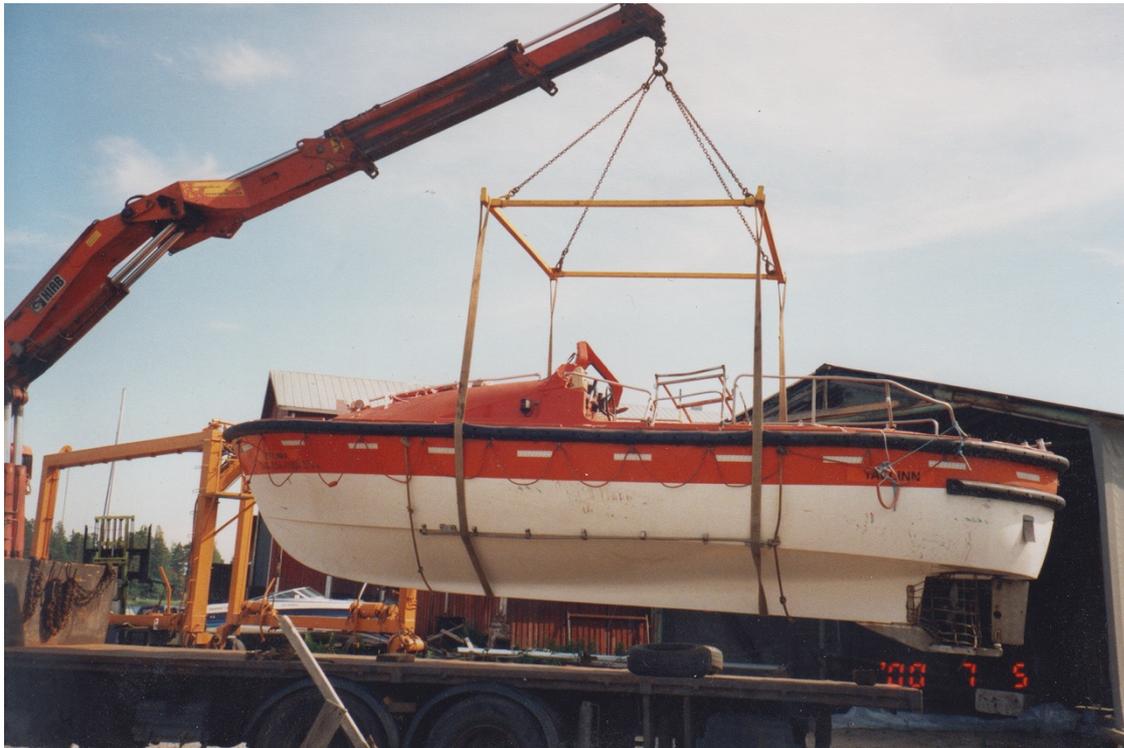
Damage report picture 3. *Crane lifting the MOB boat at the Hanko free camp. Note damage in hull, scratches and color marks from MV Estonia bottom blue antifouling color. Severe damage on the railing and windscreen. The roof of the front cab was cracked. Photo: Lars Andersson.*

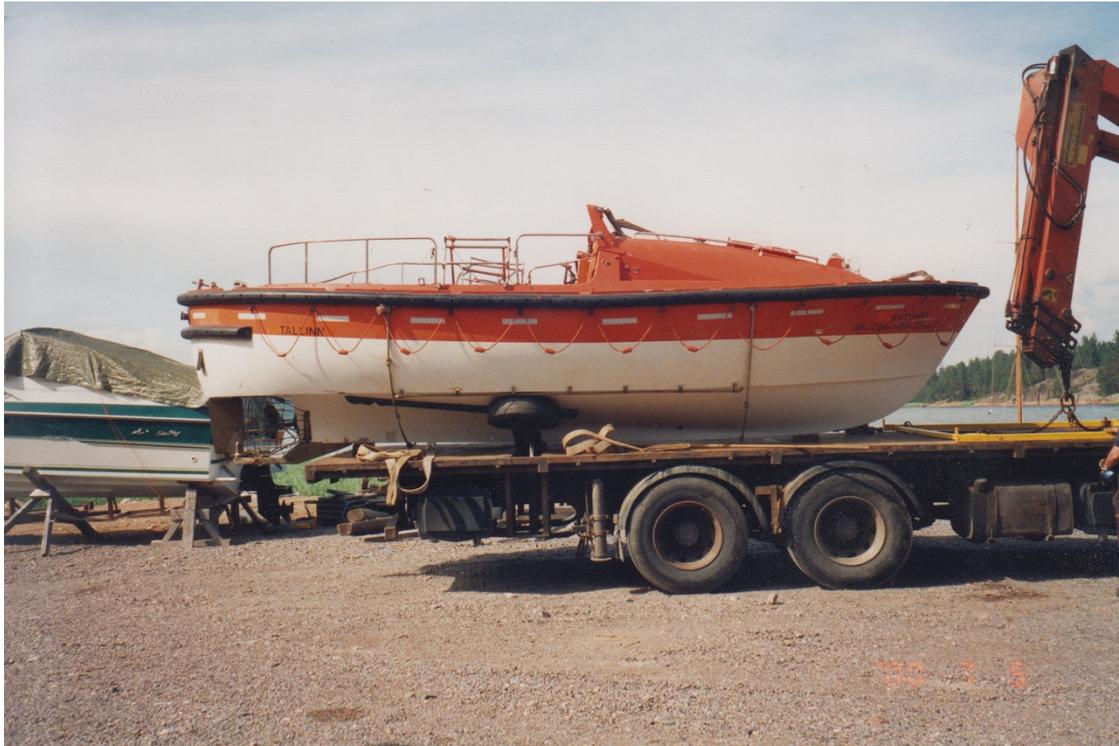
Damage report picture 4. *The starboard side lantern was missing. Photo: Lars Andersson.*

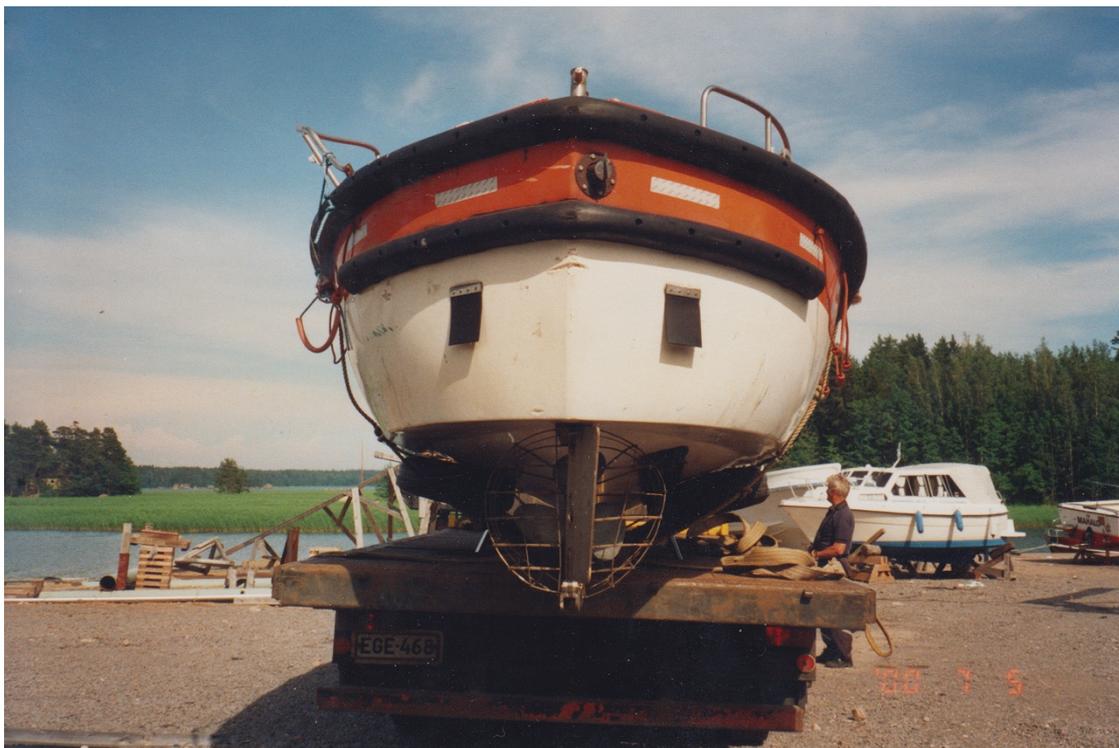
Damage report picture 5. *The stern with blue antifouling color on the port side and an almost horizontal crack in the middle-upper part of the hull. A number of holes and cracks in the aft port side of the hull. The propeller cover was jammed. Severe damage on the port side railing. Photo: Lars Andersson.*

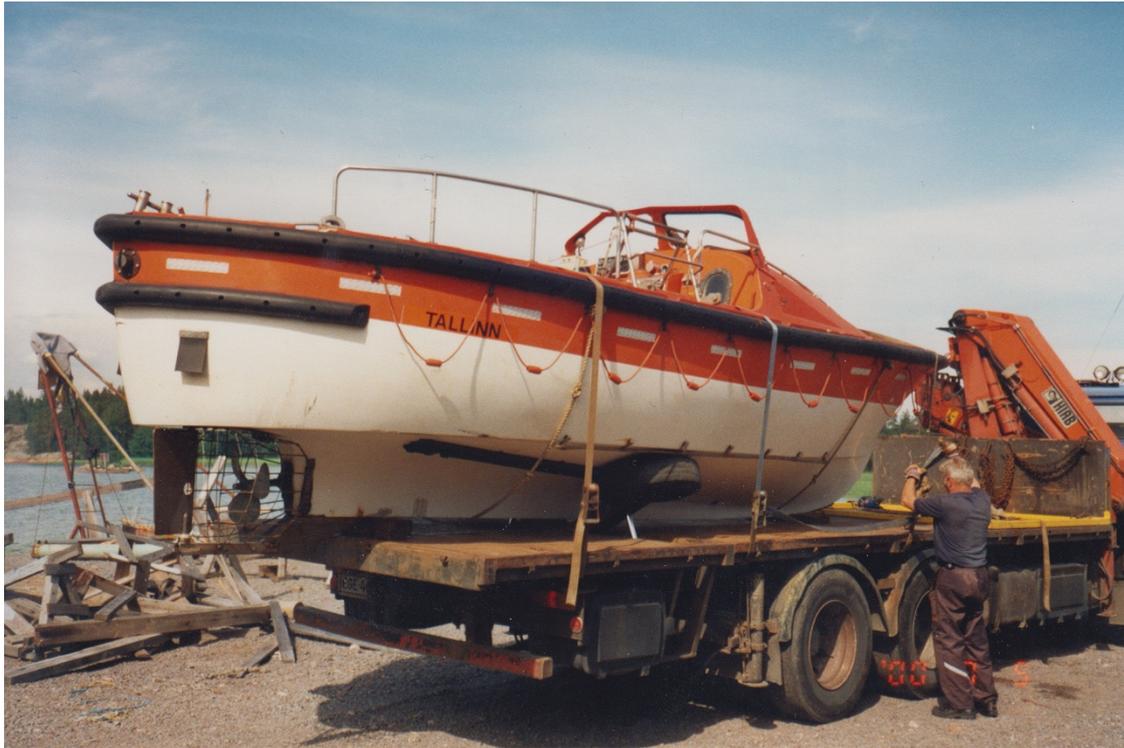
Damage report picture 6. A number of minor scratches on the starboard white painted hull. Photo: Lars Andersson.

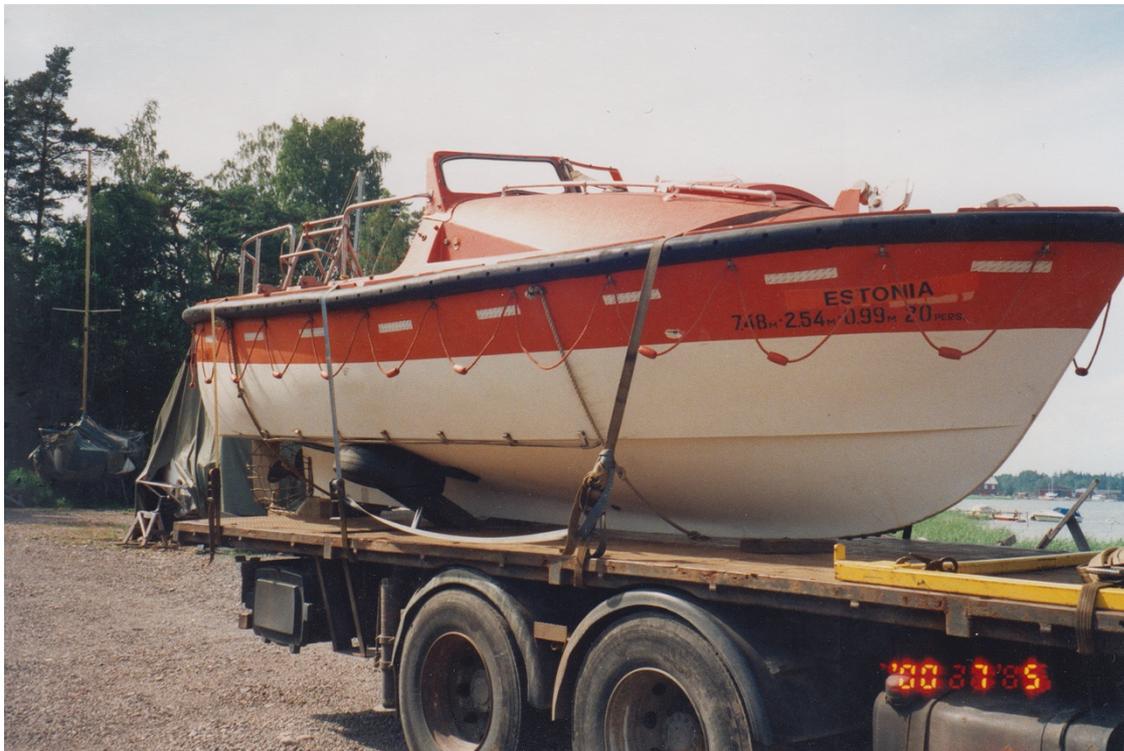
Damage report picture 7. A hole in the orange painted hull just aft the marking "7.48 m." The lighting mast only had the deck bracket left. Photo: Lars Andersson.

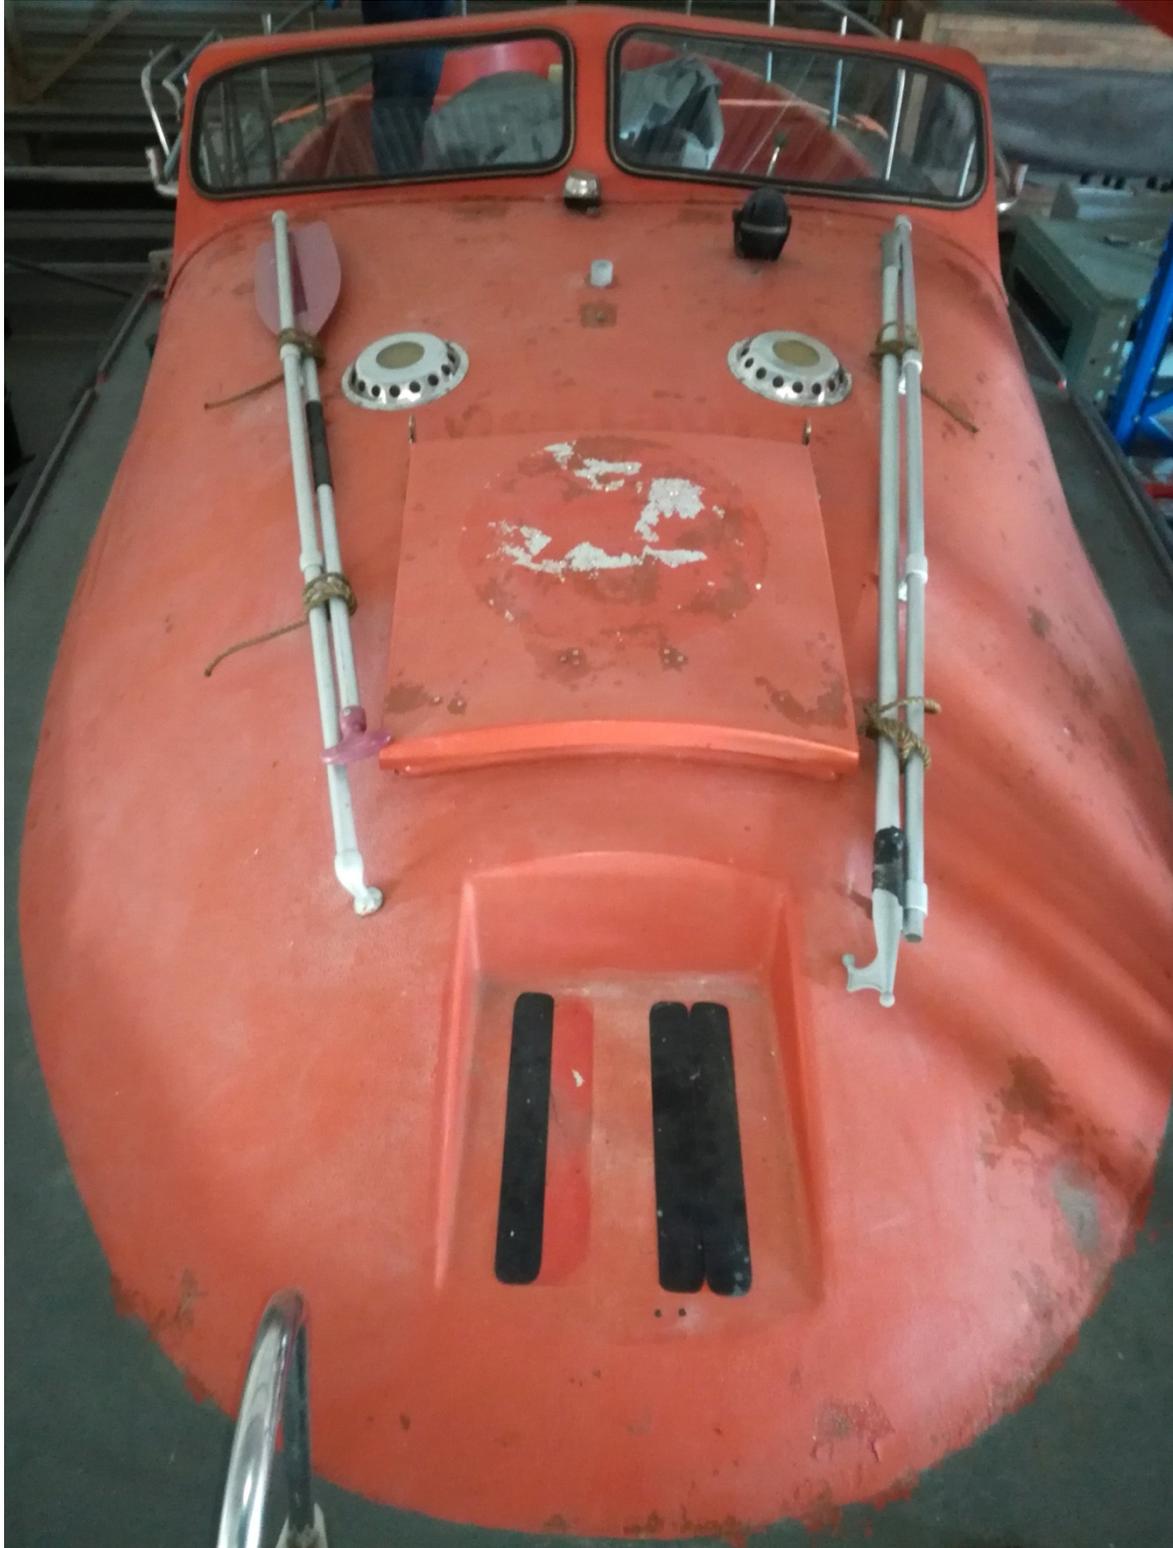
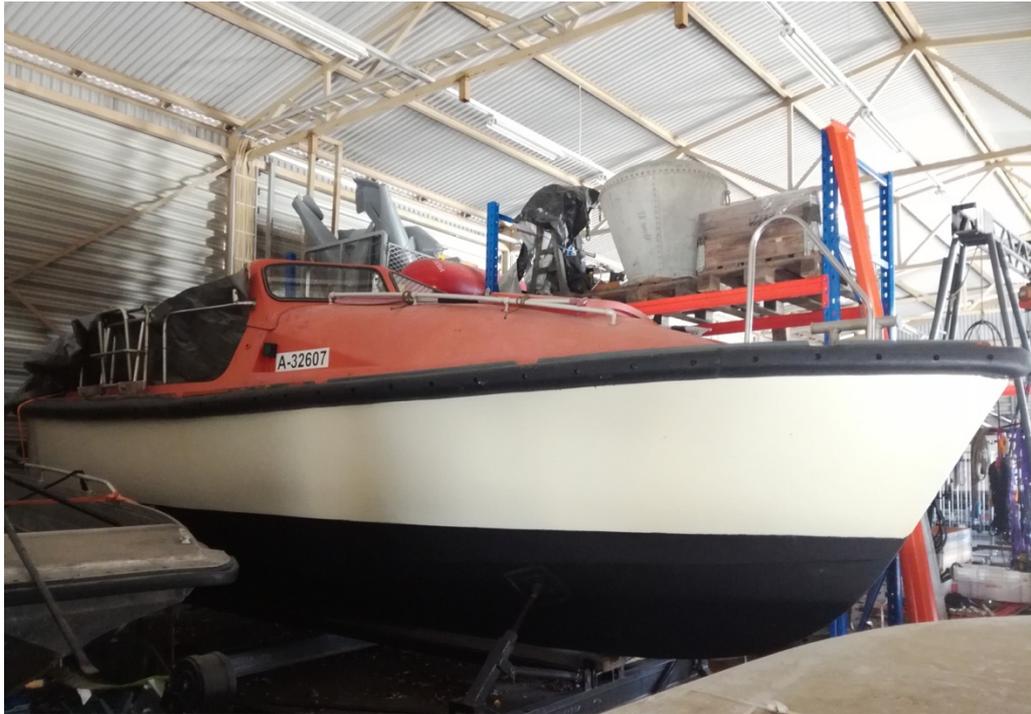
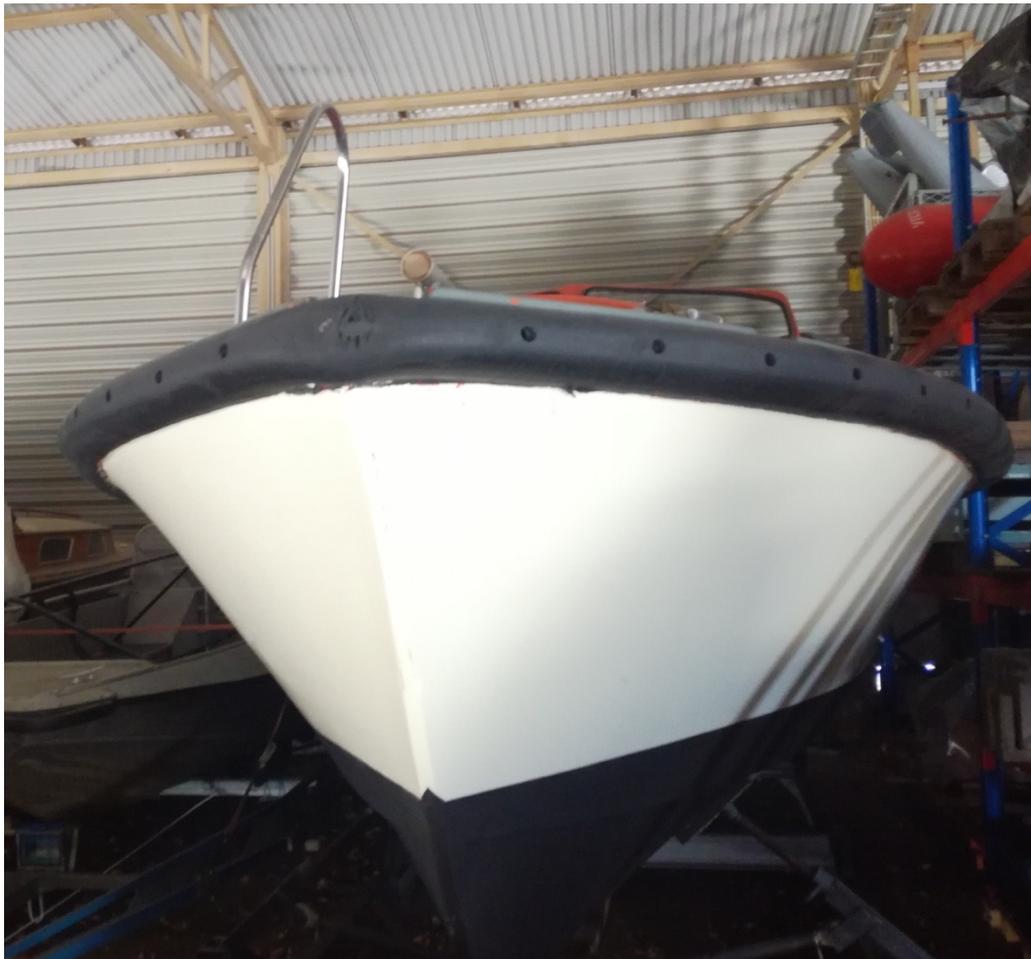
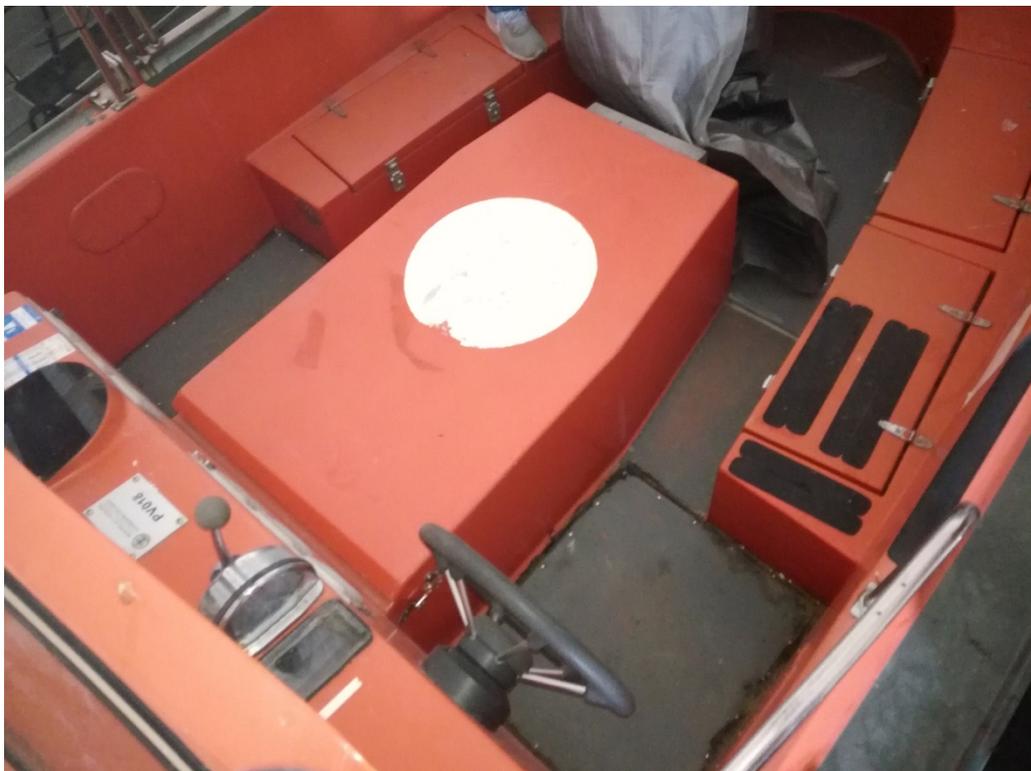
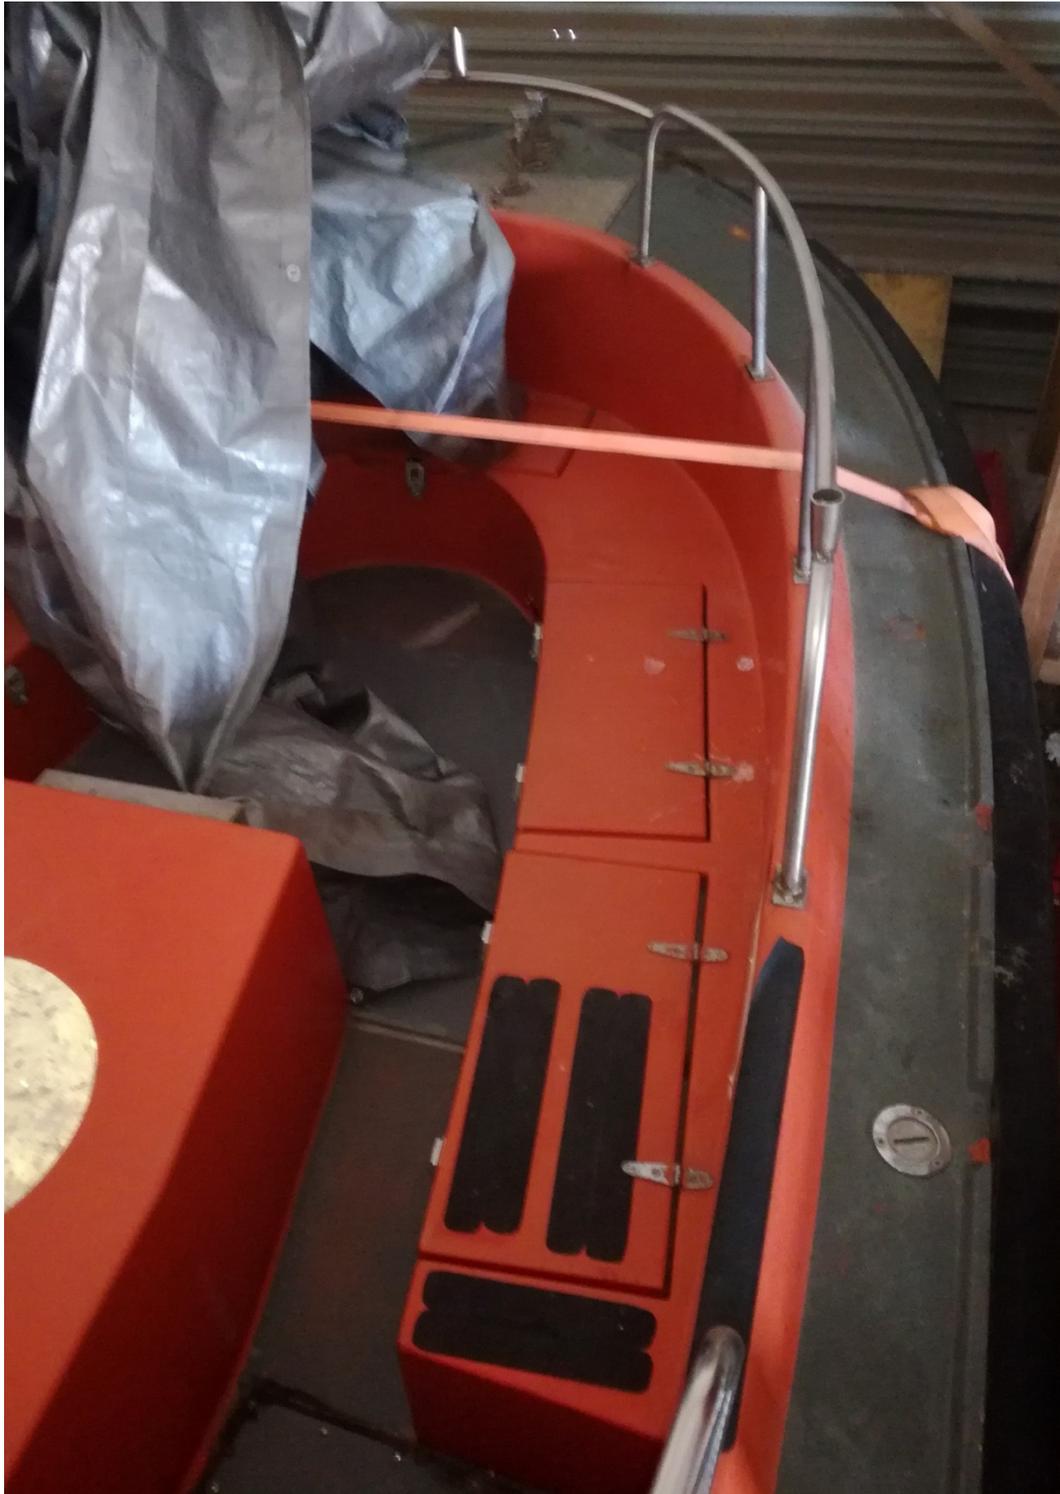
The boat, which in 2002 had been renovated to top condition, has not been maintained and is in poor condition. It is stored in Forum Marinum's repository and is not exhibited to the public.

In appearance, the boat has decayed to a condition that is almost similar to the condition it was in before the sinking.
