The Independent Fact Group

Subject: MV Estonia shipwreck scenario

Type: Report

Date: 2022-11-10

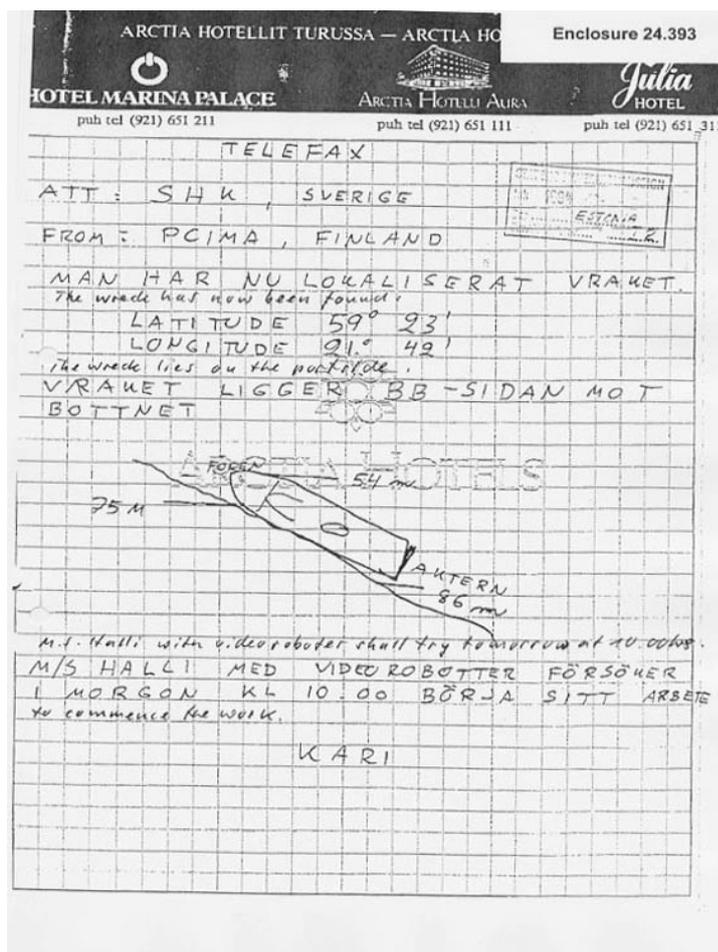
The Finnish accident investigation authority issued an utterly false position at Latitude 59°23' and Longitude 21°42' through its chairman Kari Lehtola 1994.09.30. The intent was, according to Lehtola, an "isolation of the wreck" to prevent other countries governments and agencies and others from conducting dives on the wreck.

Figure 1. The false position was communicated via fax to SHK in Sweden. (German Group of Experts enclosure).

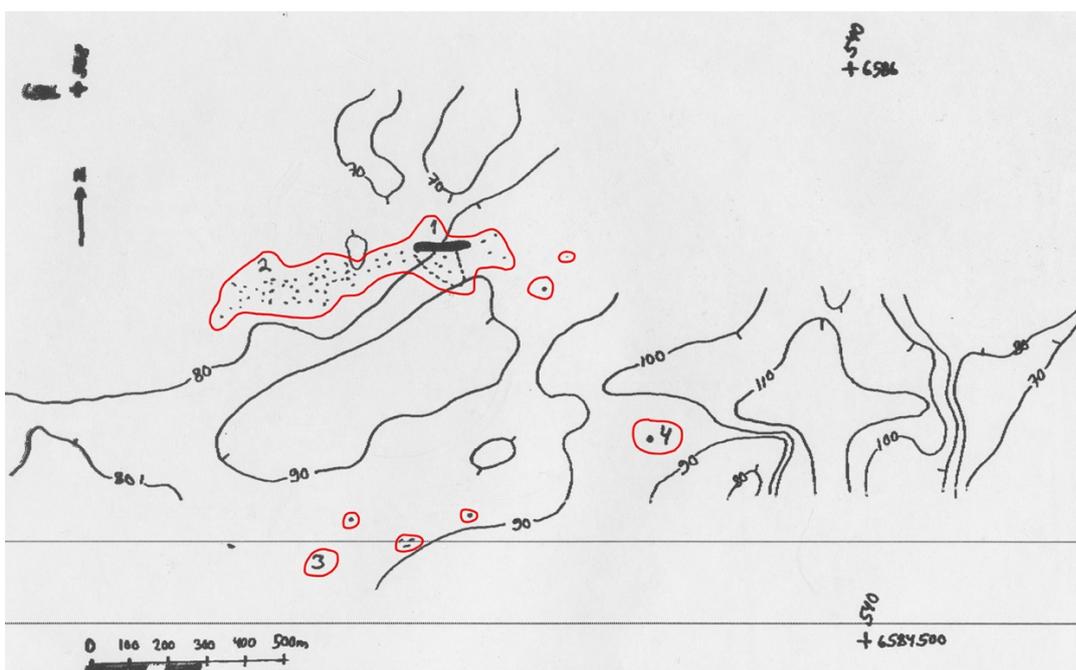
Figure 3. Dr. Jouko Nuorteva, map and findings from the bottom surveys (red markings, the Independent Factgroup).

On the map (Figure 3) that Dr. Nuorteva attached after the first bottom surveys, we marked the bottom findings with red to make them more transparent. Nuorteva described the various findings regarding 1, 2, 3 and 4 in his letter.

Nuorteva concluded that MV Estonia must have passed place 4 and place 3 at her entry into the shipwreck area.

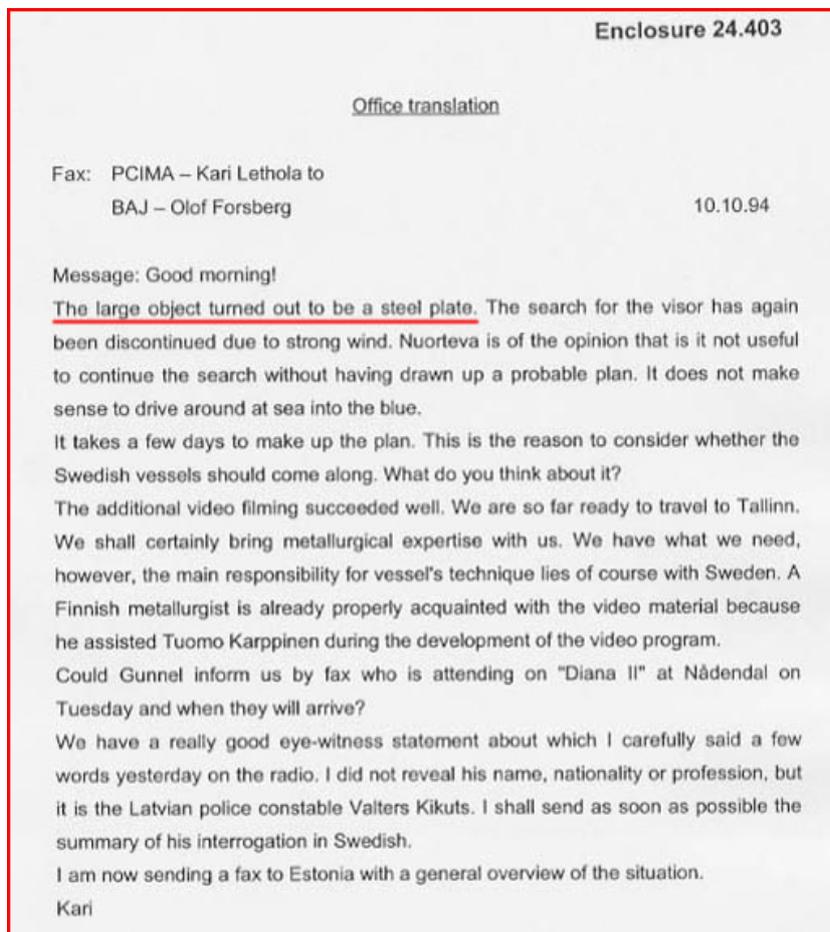
The next day, October 10, Kari Lehtola briefly announced that the large object turned out to be a sheet of steel. Unfortunately, no additional information, images, or video footage complements this brief description. However, it has never been denied that the object came from MV Estonia.

Figure 5. From Kari Lehtola via fax to SHK in Sweden. "The large object was a steel plate" (German Group of Experts enclosure).

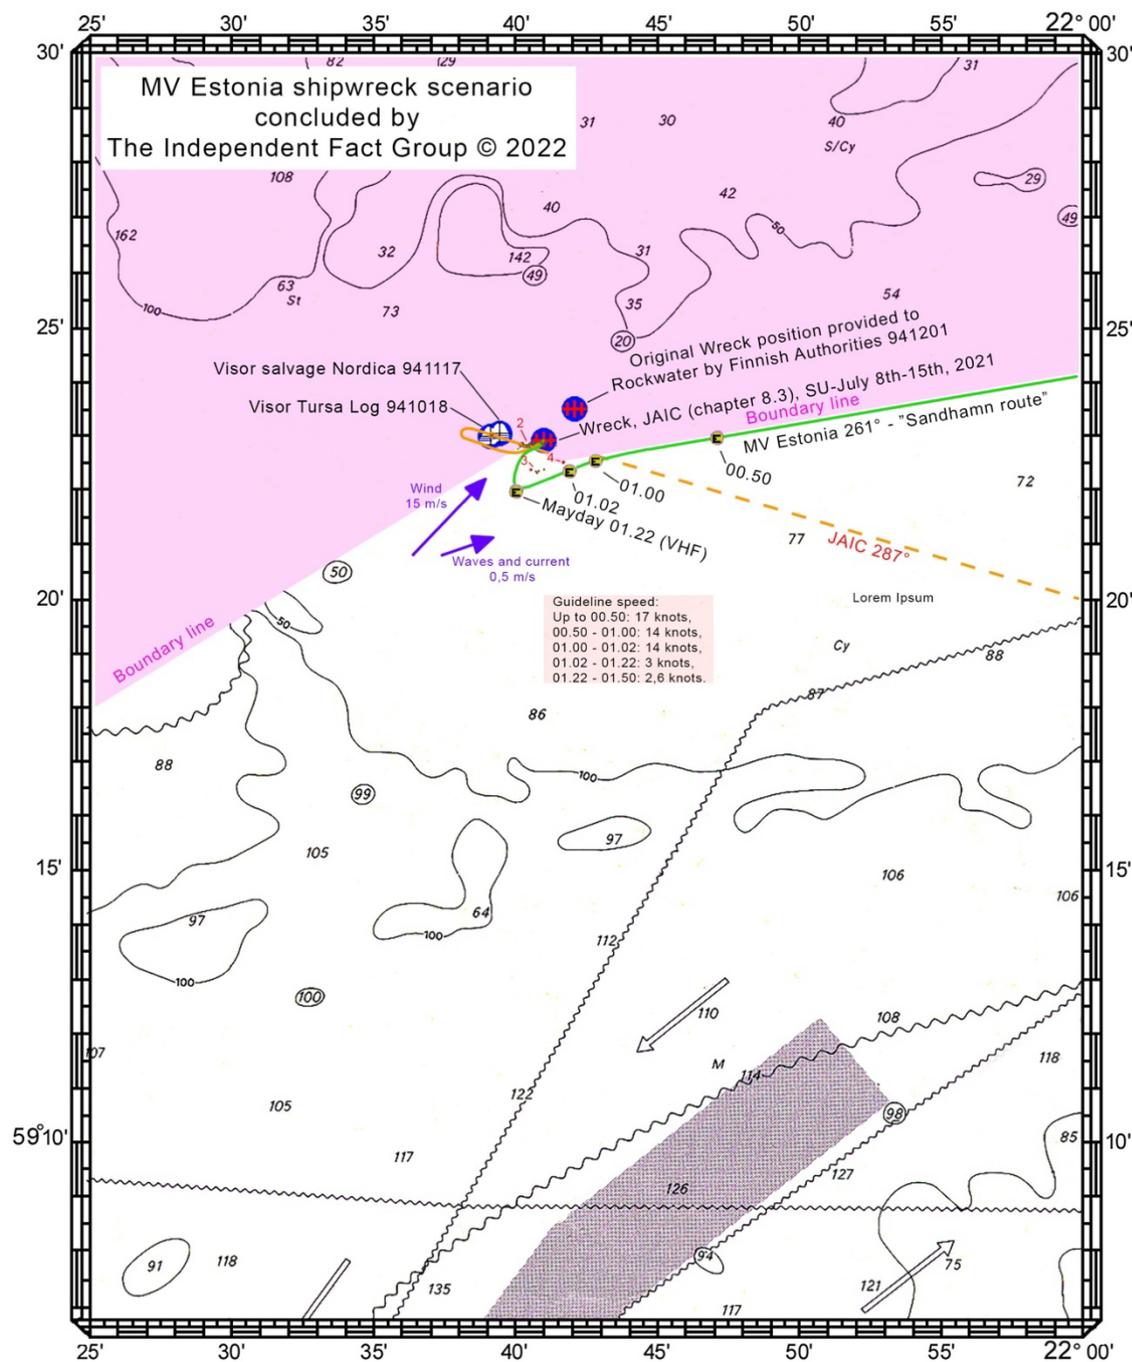
MV Estonia entered the area on course 261 degrees, and she maintained a speed of approx. 17 knots until 00.50. Earlier in the evening, when Estonia was on its way toward Sweden close to Mariella and Silja Europa, she held a slightly higher speed. It was possible because the wind was weaker and the waves lower.

According to our investigations compiled from facts, Estonia's route was up to the sinking south of the boundary line.

The shipwreck area had a southwesterly mean wind of around 15 m/sec. Waves and current resulted in a direction that, during the last hour, met Estonia almost straight in front.

Figure 4. An overview of the shipwreck site.

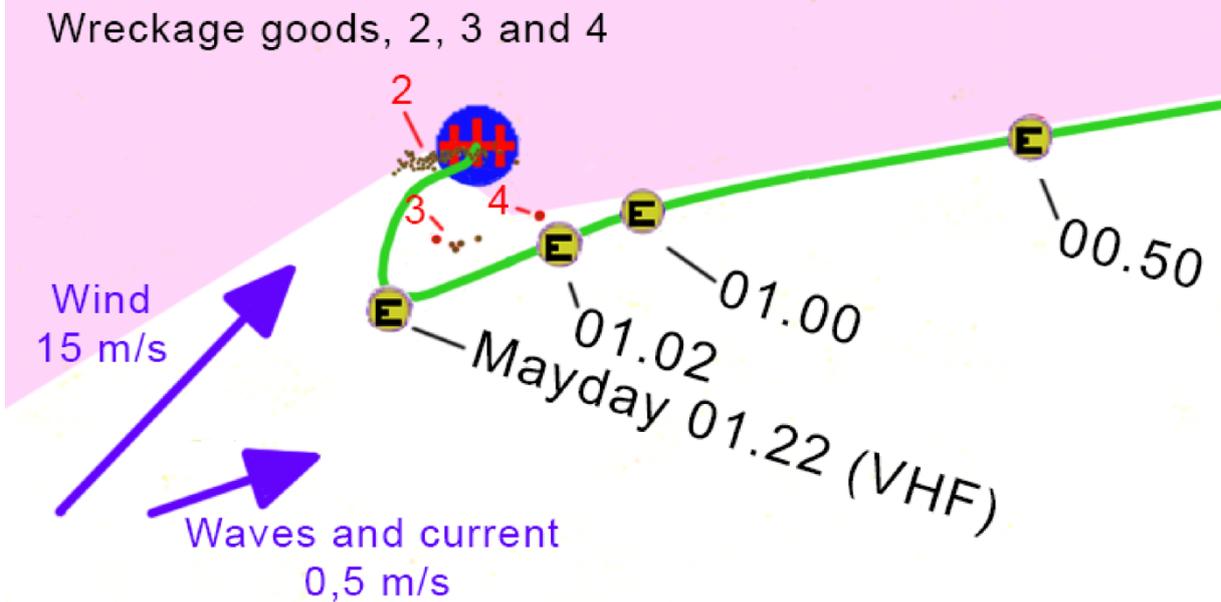
As the ship drifted northward, it sunk more and more into seawater, whereby the influence of the wind decreased, and the vessel then drifted more and more westward. The final course before the sinking at about 00.50 was around 60 degrees.

We can state that close to the location of the shipwreck, Nuorteva found a large number of objects on the bottom (location 2). Nuorteva call this area “the fall aera” and it can be explained due to the fact that MV Estonia "turned turtle".

Figure 5. A close up of the final course and drifting at the shipwreck site.

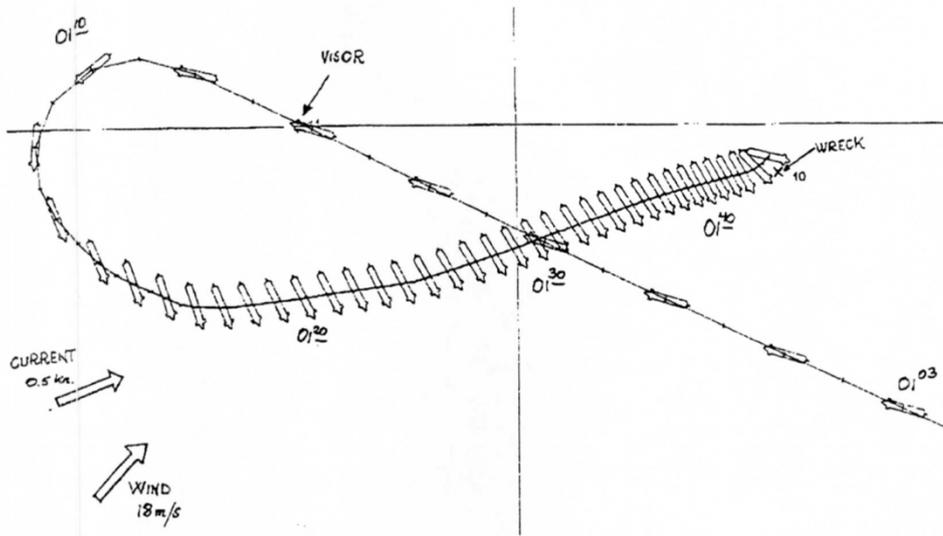
The ship heading before the visor was lost was assumed to be 290° and the wave direction was assumed to be 245° which equals an initial relative heading to the waves of 135°.

Figure 4.9 Plot of simulated track of the ESTONIA, Example 1.

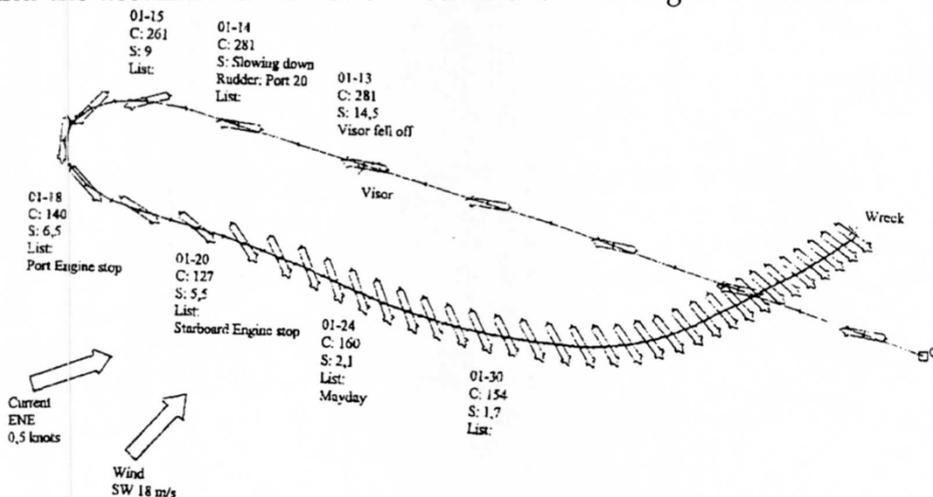
Figure 4.12 Plot of simulated track of the ESTONIA, Example 2.

Note that the image in Example 2 differs from the version published in the final report 13.12. In the final report, JAIC claims that the maritime Academy made the plot in Kalmar. But we can see that the simulation was clearly deviating.
