Subject: The missing part of the MV Estonia Car Deck

Type: Statement

By: The Independent Fact Group

Date: 2025-01-01

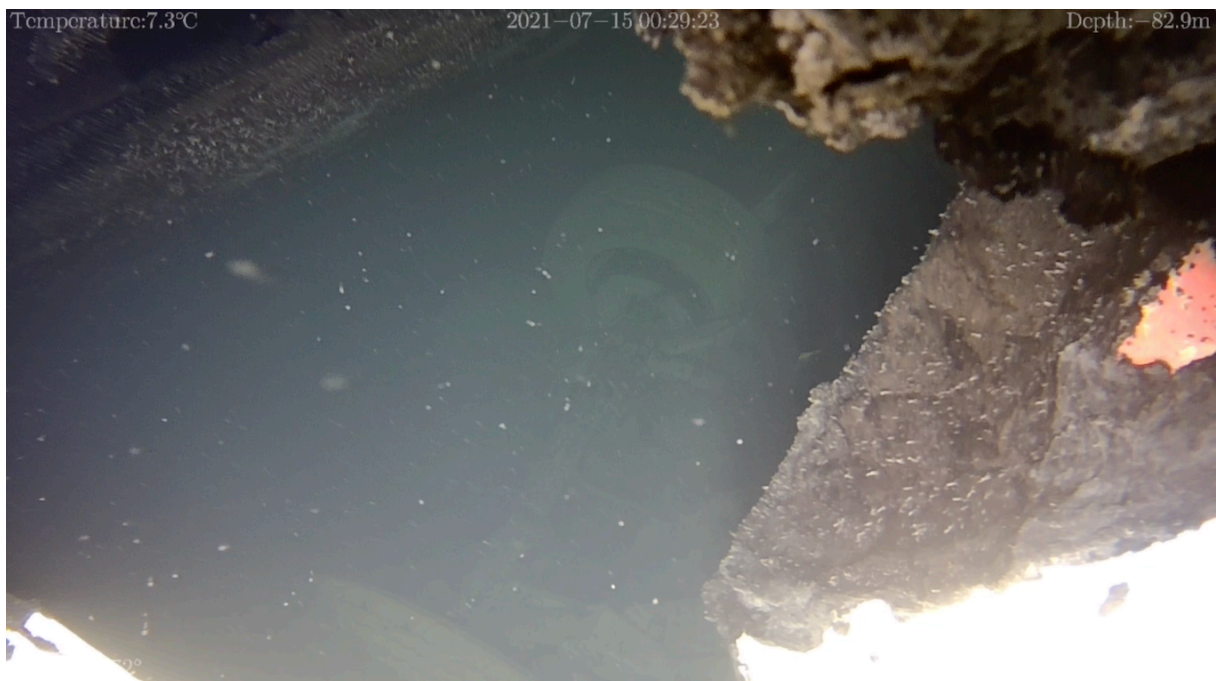
The ship's fender is placed at exactly the same height as the plate that forms the driving surface on the car deck. Below this line, you can see the car deck. However, the video films show that you can see into the car deck because the car deck itself is missing inside the hole.

Picture 1. A closeup from the video where the underside of a lorry is visible.

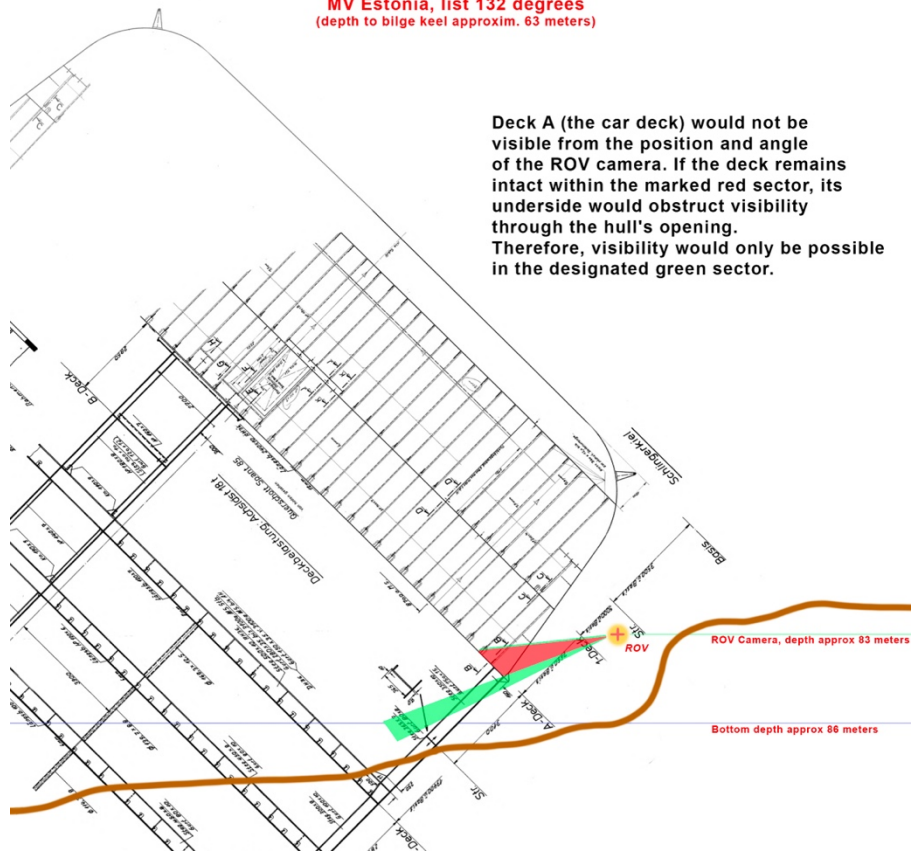
MV Estonia, list 132 degrees
 (depth to bilge keel approx. 63 meters)

Picture 2. An overview of the ship, hole, and ROV position.

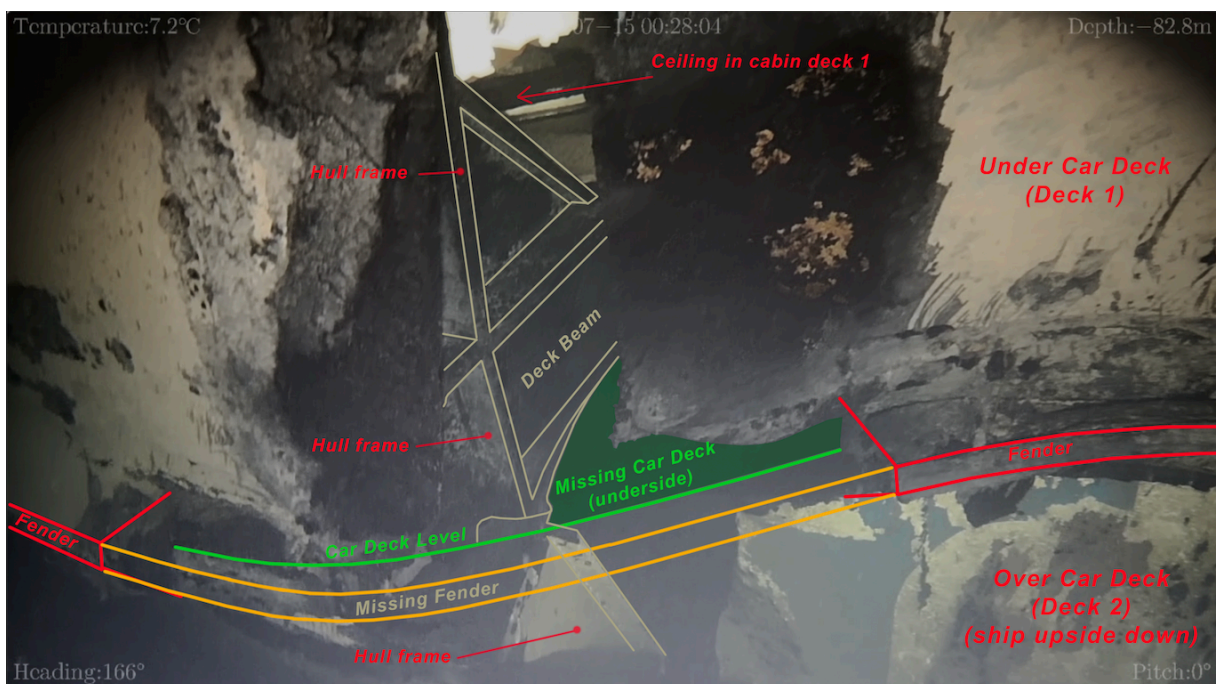
The missing car deck also formed an integral part of the supporting beams that lay like a net under the car deck. The transverse beams were 380 mm high and had a material thickness of 8 mm. In between were longitudinal beams, 240 mm high and 10 mm thick. The plate on the car deck was 12 mm.

It seems remarkable that a significant part of this structure is missing inside the hole in the hull, which can be seen to the left in the picture.

Picture 3. The full view of the photo from the ROV video outlined with guidelines for understanding.

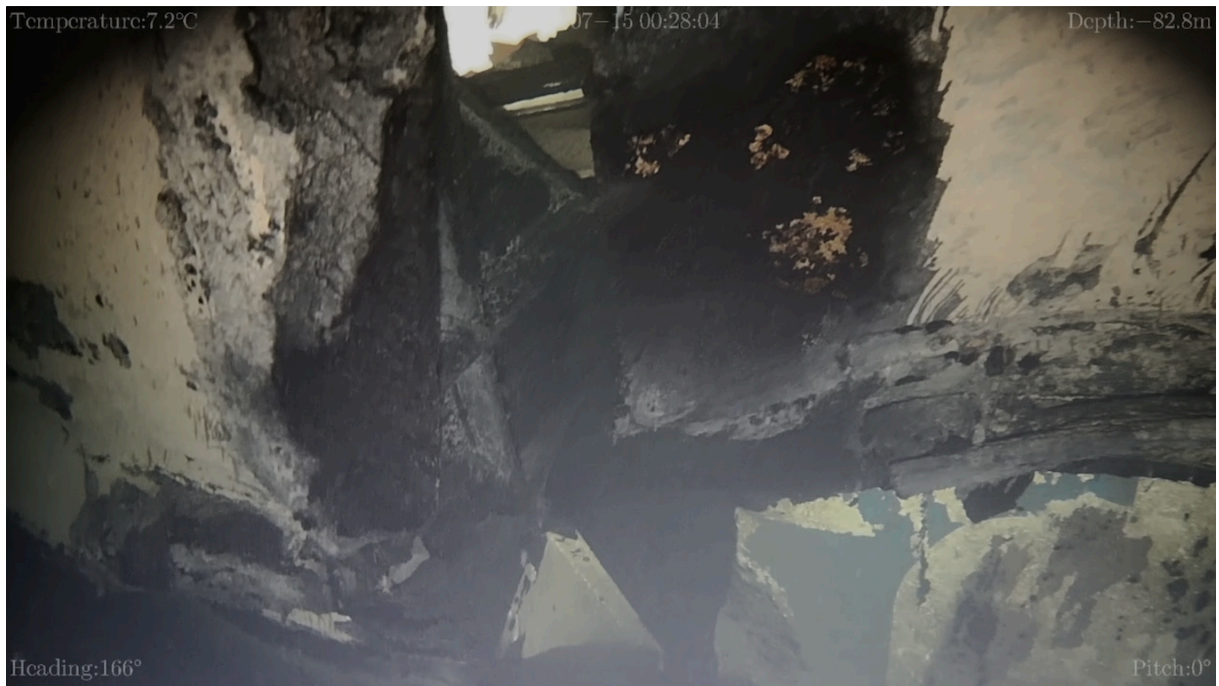
Picture 4. The full view of the photo from the ROV video without guidelines.

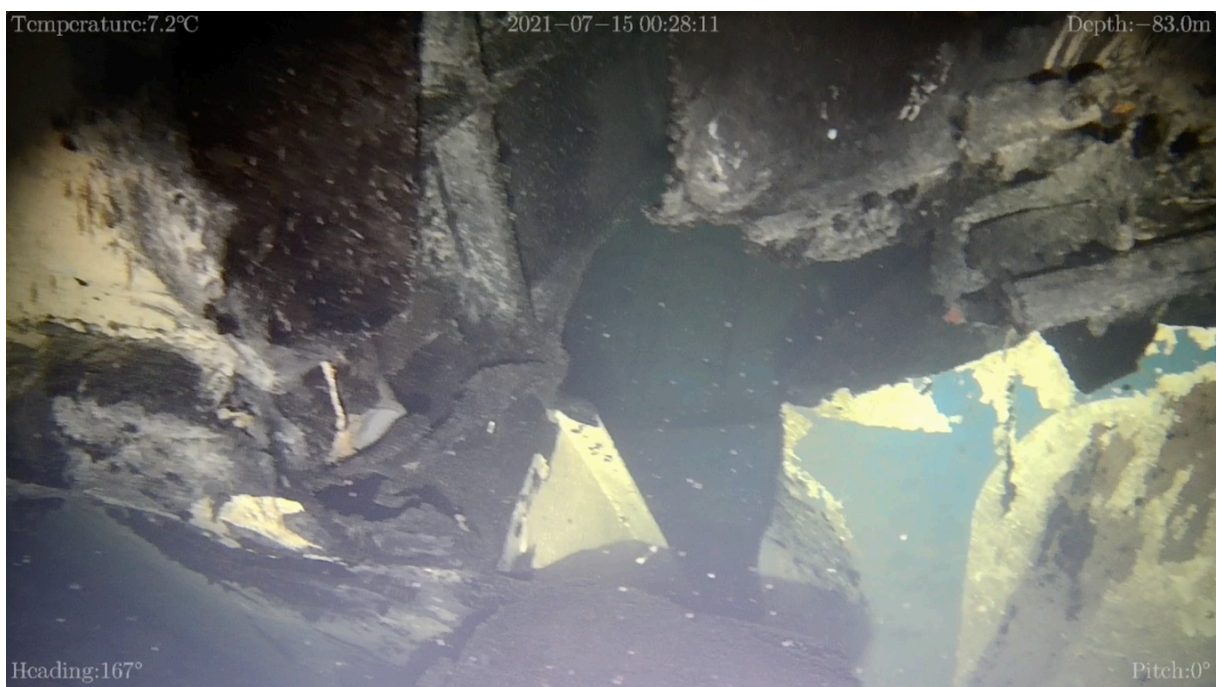
Picture 5. The full view of the photo from the ROV zooming in close to the hole.

What caused the car deck and structure, including the fender, to disappear?
