# The Independent Fact Group

Subject: The conspirators

Type: Analysis

Date: 2022-02-10, revised 2022-02-12

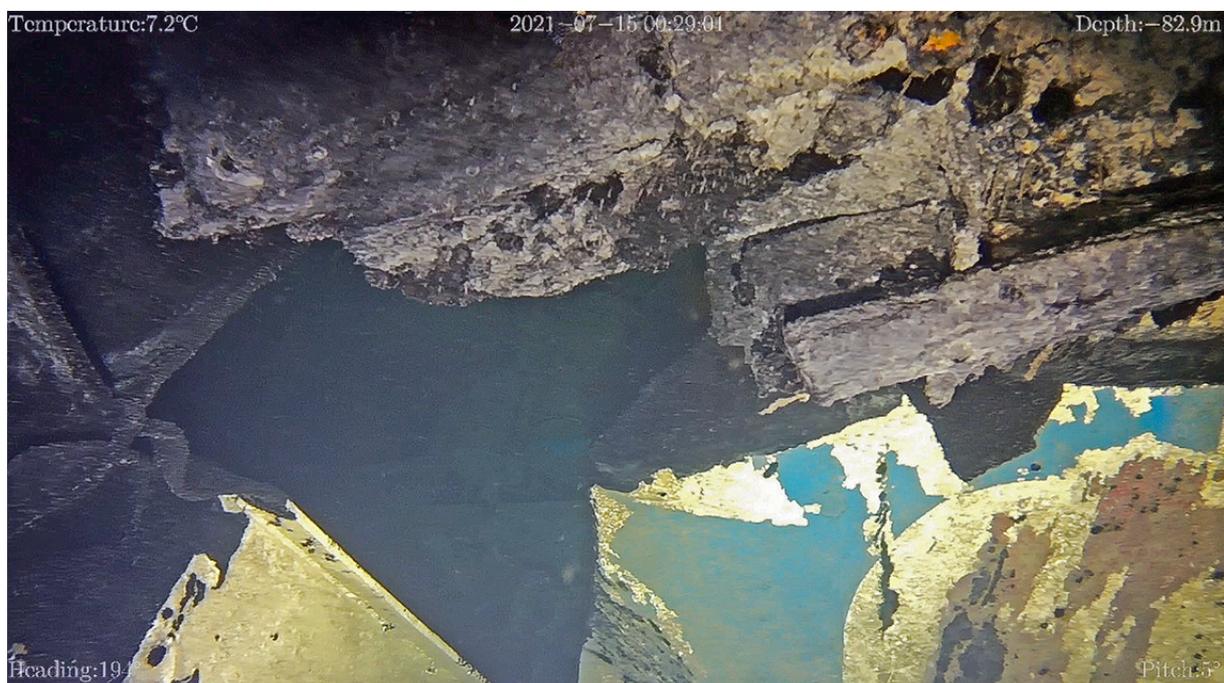
The images we have chosen to use here are in a quality not revealed before. They show the two large holes, each of them has an area of about 4 square meters.

Picture 1. Close up of the first documented hole in the hull, opening up a large damage into the car deck and also into the deck below the car deck.

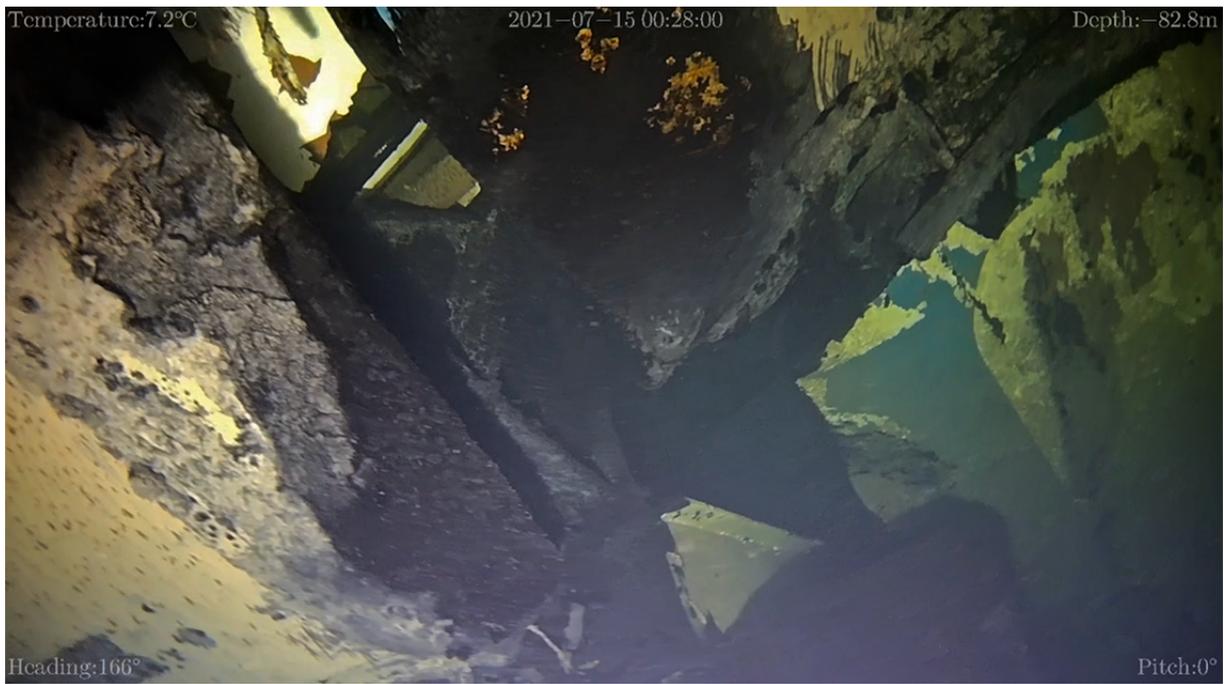
Picture 2. The first documented hole in the hull in another angle showing the extensive damage where the hull plating has been torn out from the ship.

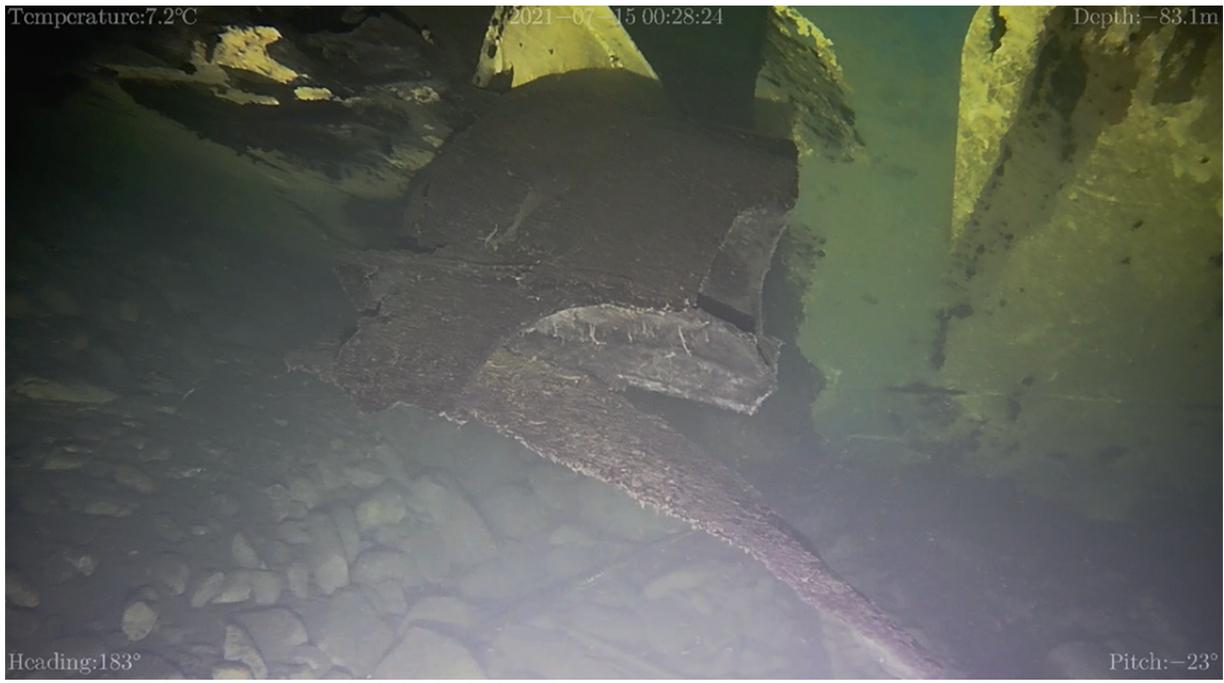
Picture 3. The first documented hole in the hull. A larger piece of the ship's hull plate heavily bent and protruding 50 - 70 cm outside the hull side.

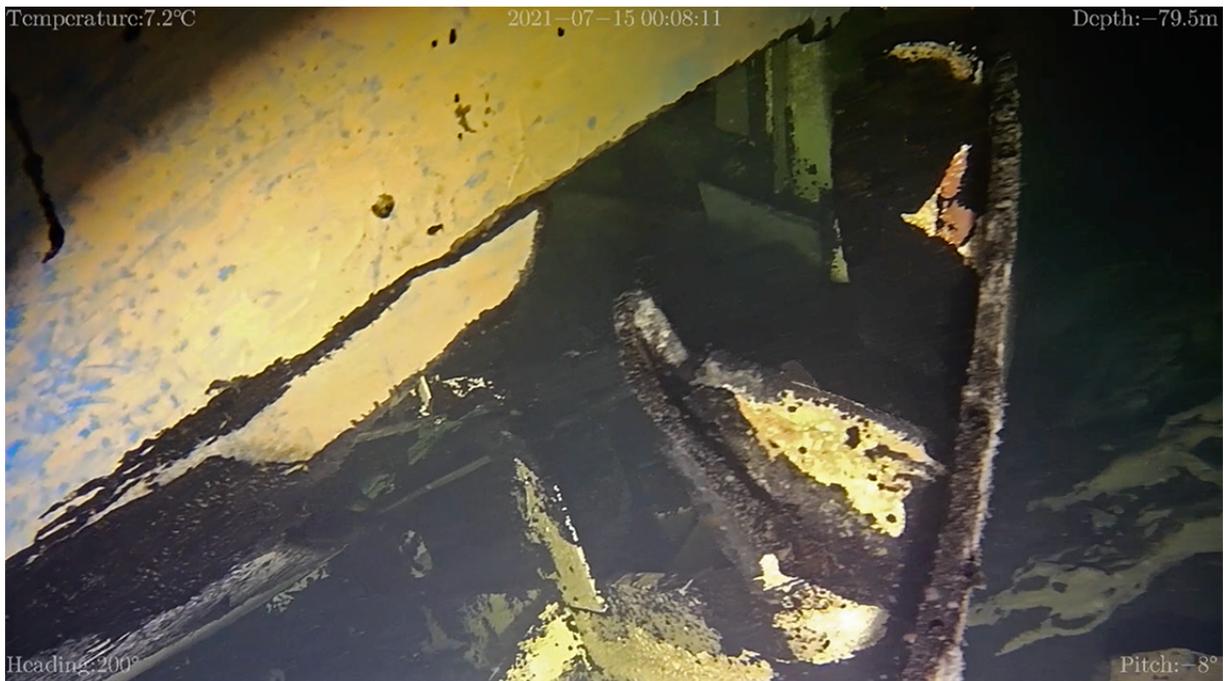
Picture 4. The second documented hole in the hull showing the extensive damage well under the waterline where the hull plating also has been torn out from the inside of the ship.

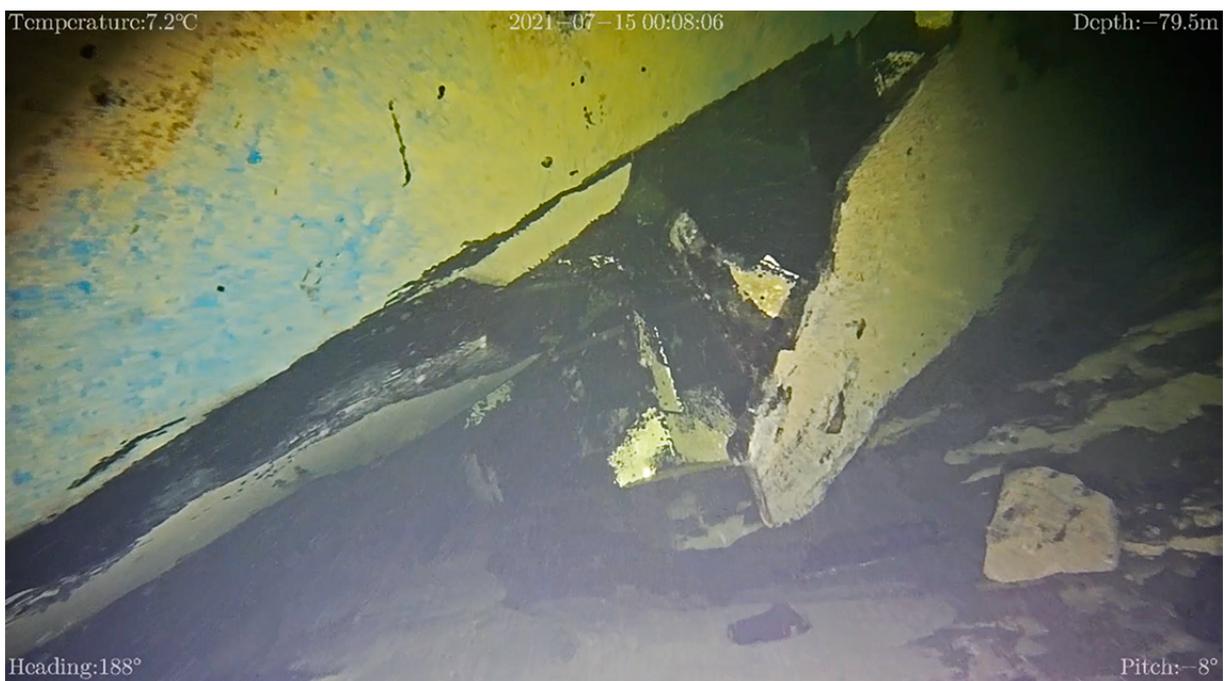
Picture 5. The second documented hole in the hull in another angle.

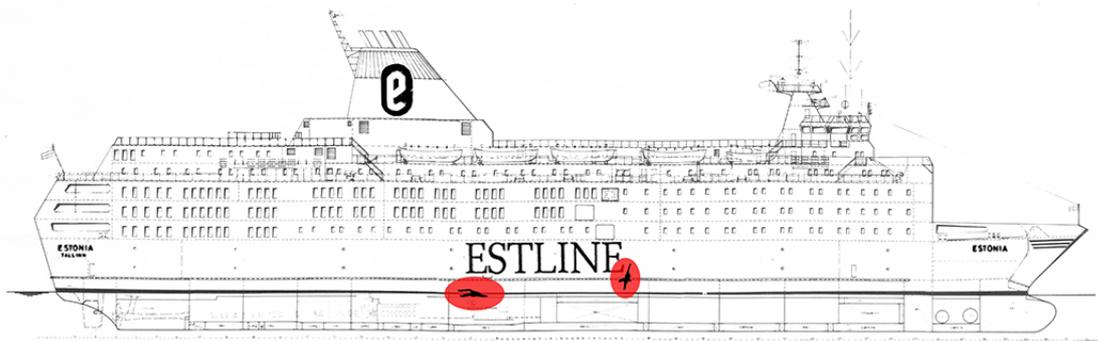
We now know that there are such holes in the ship's starboard side.

Picture 6. Placement of the first (right) and second (left) documented holes in the hull.

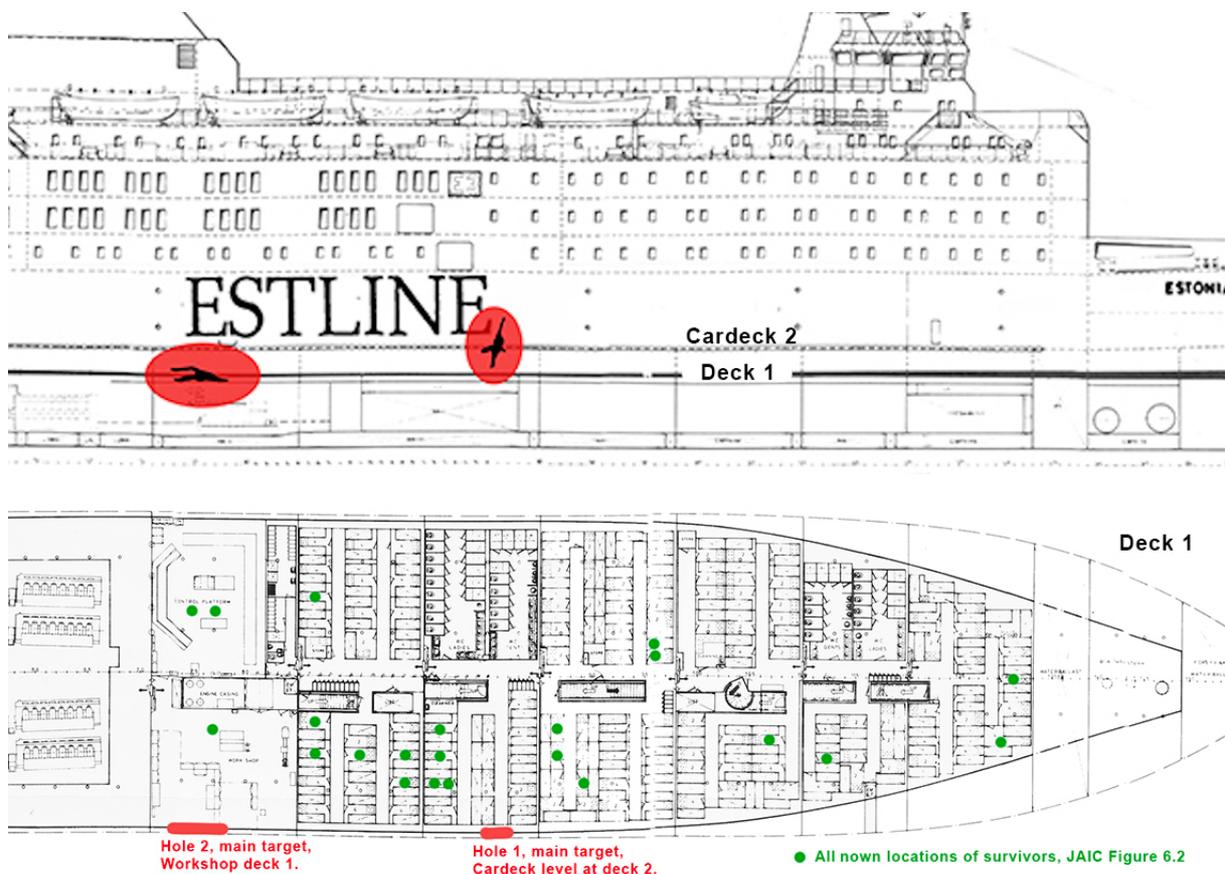
Most of the survivors from deck 1 had cabins near hole 1 on the starboard side. However, no one had a cabin in the cross corridor where the hole occurred. It could mean that they got an early warning.

Picture 8. Overview of deck 1 and location of survivors, impact of damage at deck 1 and 2.

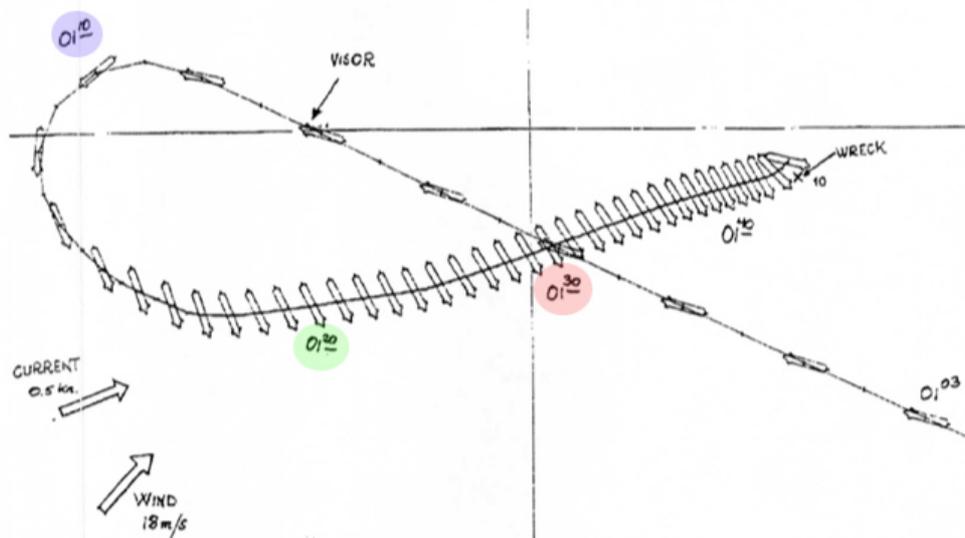
Picture 7. The plot during the last hour according to JAIC Supplement 522.

This simulated plot shows how the ship lost its visor and then drifted towards the sinking site. Note that the visor was lost before 01.10 and then the ship turns to port and around to cross its own route at 01.30.

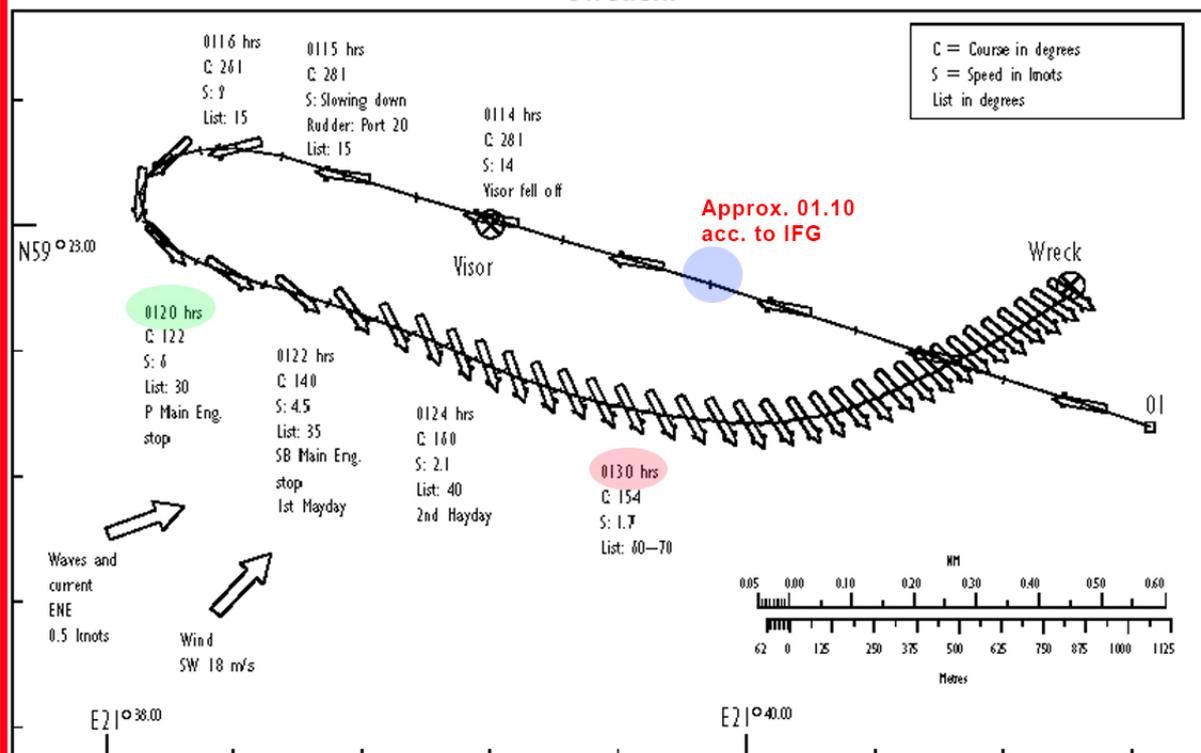
These three different time indications, according to the Supplement 522, are to be compared with the description below from the final report where visor was lost 01.14. At 01.30. Estonia had a distance of around 1000 m left before she should cross her own route.

Picture 8. The plot during the last hour according to JAIC final report 13.2.1.
