Subject: The visor floatability and impossible sinking scenario

Type: Analysis

By: The Independent Fact Group
www.factgroup.uk

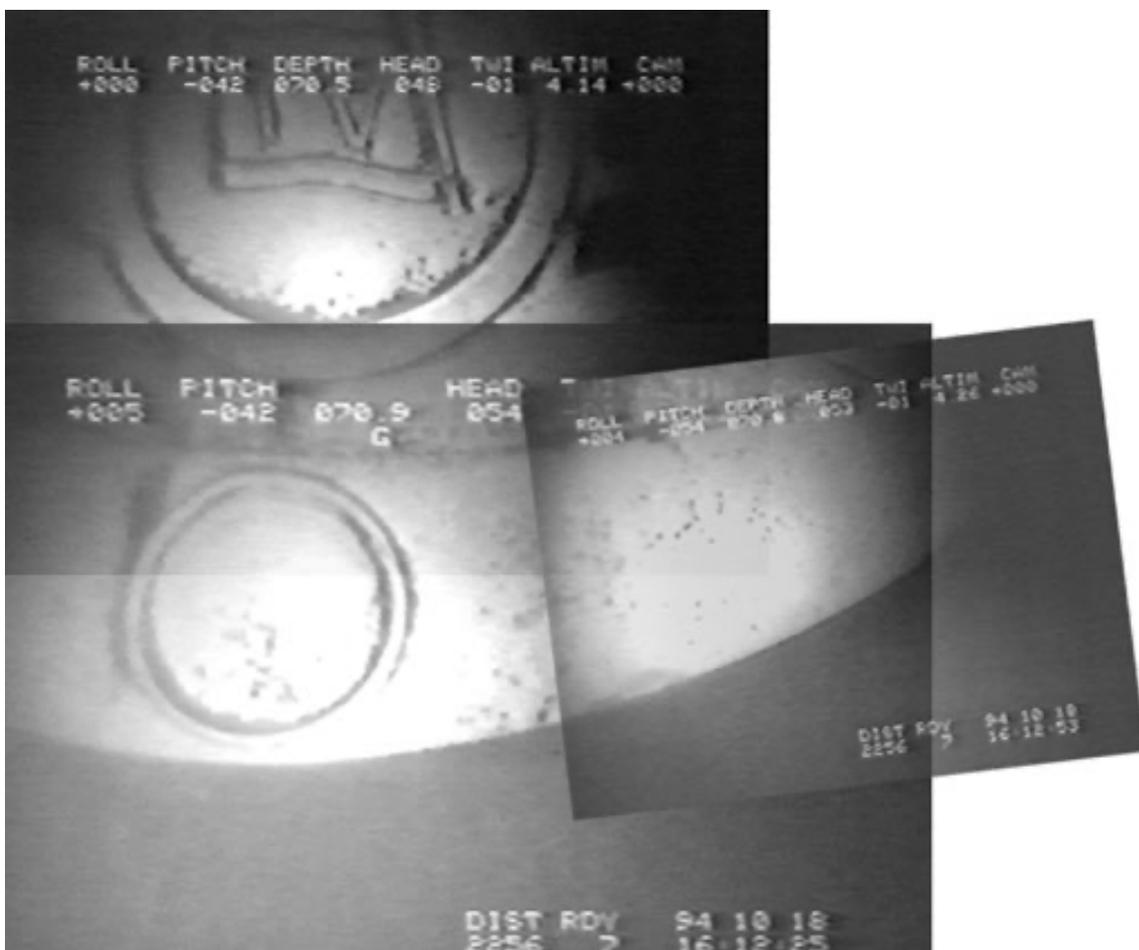
Picture 1. *The upper forward part of the visor standing upside down in the soft sediment. The forward part of the visor was not in contact with the seabed.*

From a video recorded by the Finish authorities on 18 October 1994 (Finnish archive "visiri 17-18/10 -94"), the visor position can be seen on the bottom of the Baltic. The visor was standing upside down with all of its gunwale (the upper part) free from the seabed. The only parts of the visor that had sunk in the mud were the visor arms and the ramp's housing. See also Picture 2 below.

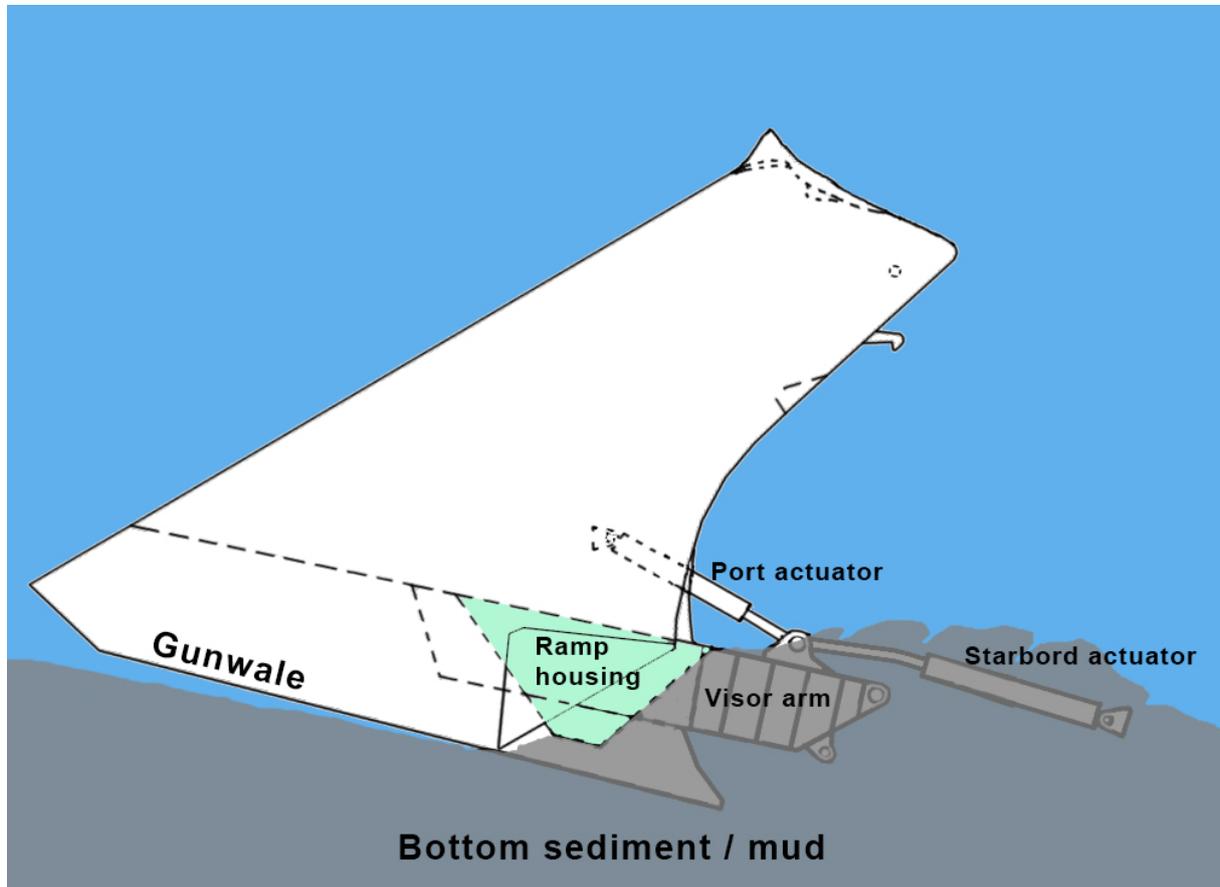
In a telefax 26/10 1994 from Kari Lehtola (Finnish Accident Investigation Board) to Olof Forsberg (Swedish Accident Investigation Board) there is an enclosure, "A preliminary summary of observations on the bow visor video" (SHK archive Estonia I 33). The visor position was confirmed as "The bow visor lies on the seabed upside down. The visor arms are buried in clay and cannot be seen. A large part of the visor operating cylinder on the right side (starboard side) is also under the clay."

Picture 2. The visor was found like this, upside down, with only parts of the visor sunk in the bottom sediment.

We also came to a conclusion, based on the tests, that it is highly unlikely that the visor came to rest upside down like it was found on the seabed. The circumstances that lead to that the visor was found standing upside down are unknown (Picture 2).

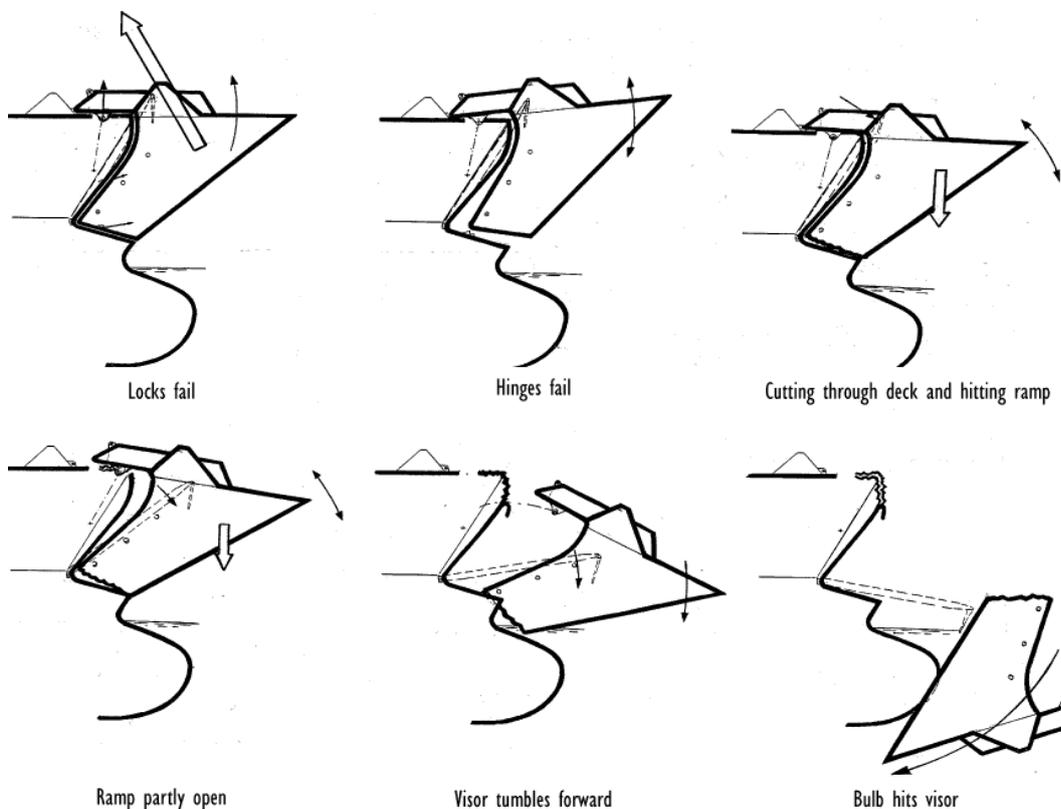
Picture 3. “JAIC Figure 13.6 Probable failure sequence of the bow visor”

We state that the description is contradictory and unclear. On the one hand, it was claimed that the visor fell off in a longitudinal motion (straight ahead) after all the locks broke in an initial stage. At the same time, starboard hydraulics have been the last part to come loose, which meant that the visor must have turned because the port's upper hinge was breaking due to overload in a twisting movement. The starboard upper hinge broke due to rotation when the visor rotated clockwise (seen from the starboard side).

First, it is described that [1] "The starboard side hinge failed as a result of twisting when the visor was rotating clockwise," and then that the rotating movement occurred [2] "After the locking devices and hinges had failed and the actuators had lost their restraining effect, the visor had a natural tendency to tumble forward ..."

These two assumptions are contradictory, [1] cannot have happened before [2], and [2] cannot have happened before [1].

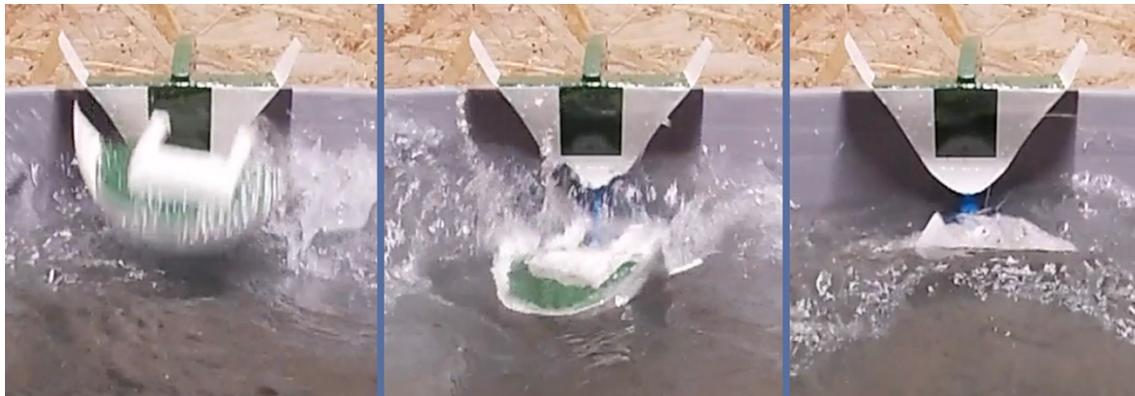
V1, the visor sunk directly,

Picture 13. The visor sunk directly, V1.

V1 occurred in 104 test drops. (74 %)

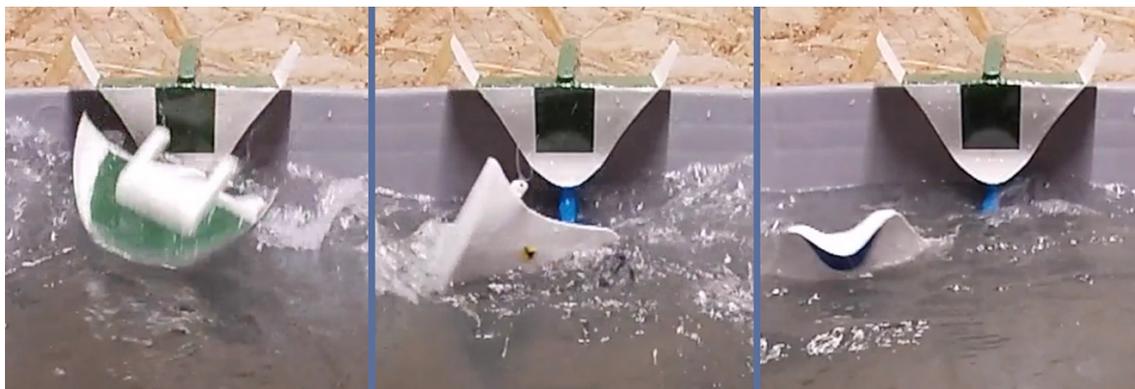
V2, the visor bounced on the water surface and sunk directly after that.

Picture 14. The visor bounced on the water surface and sunk directly after that, V2.

V2 occurred in 36 test drops. (26 %)

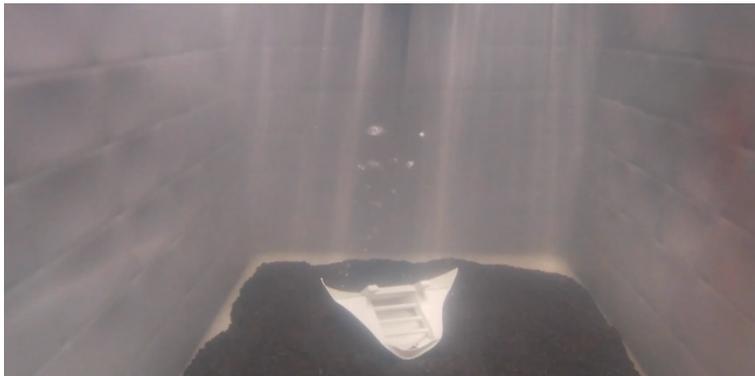
P1 occurred in 96 test drops. (68 %)

Picture 12. The visor came to rest in P1-position in 68% of the drops.

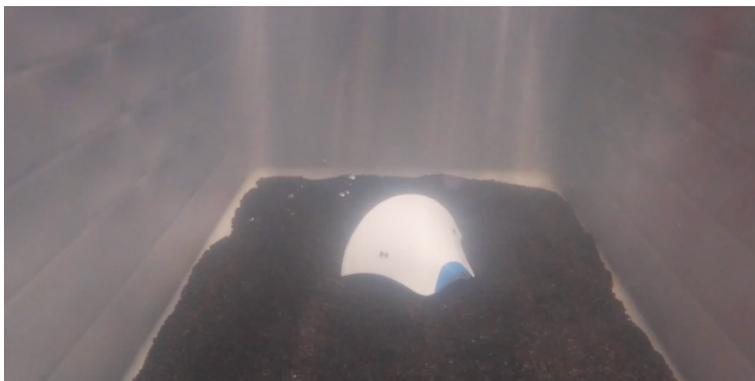
P2 occurred in 44 test drops. (32 %)

Picture 13. The visor came to rest in P2-position in 32% of the drops.
