The Independent Fact Group

Subject: Incontrovertible and final proof that the visor was detached from the ship after the sinking of MV Estonia.

Type: Analysis
By: The Independent Fact Group
www.factgroup.uk

Date: 2020-12-24

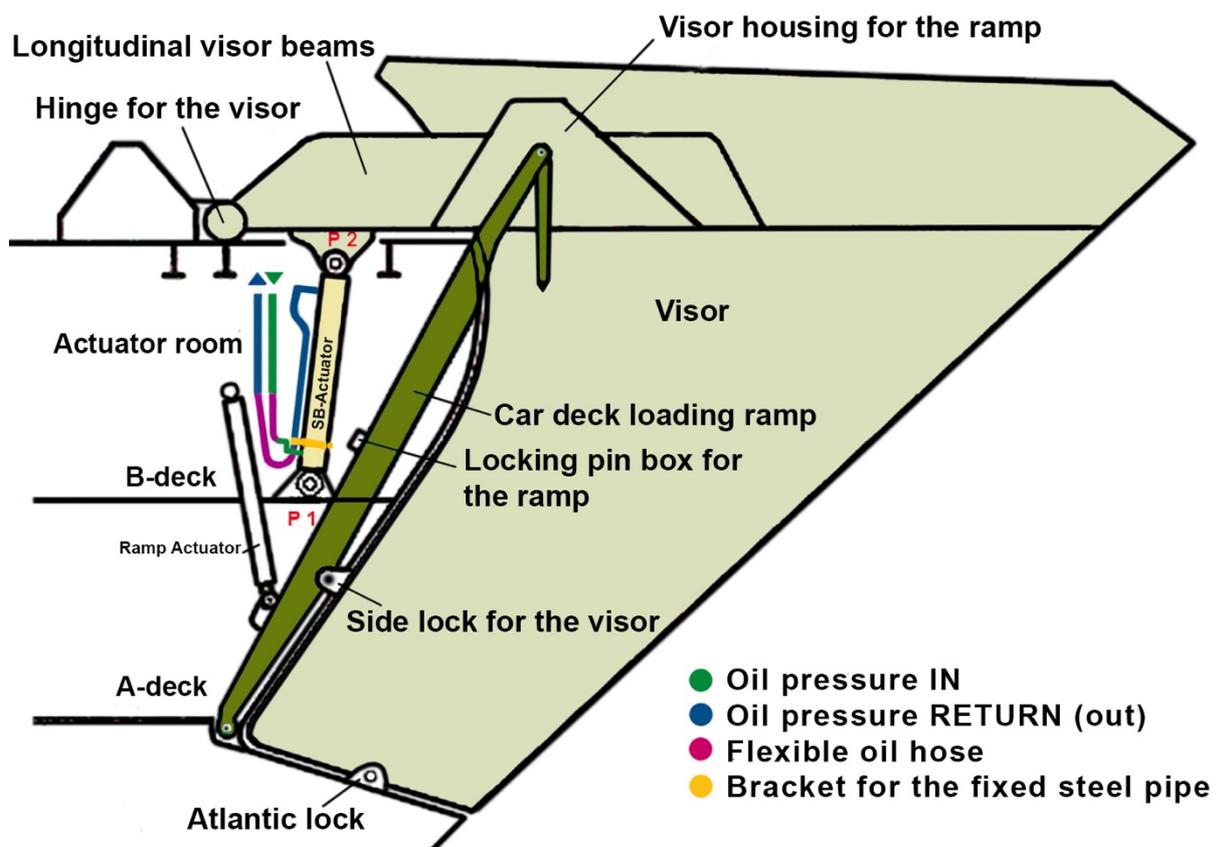
They were welded to deck B described below in picture 1 position (P 1). In the other end they were attached to the visor in the longitudinal beams, position (P 2), this at starboard and port side. The cardeck is deck A.

The oil pressure needed for the actuator was provided by one inlet and one return hose. The hoses were fixed in the actuator room to the side wall (bulkhead) and with two flexible high pressure rubber hoses to the actuator close to deck B. The inlet was attached to a 90 degree attachment pipe made in steel with its attachment sealing nut. The return hose was attached to the same kind of attachment sealing nut but on a steel pipe that was fixed in its prolonging with a steel bracket that enclosed the actuator.

Picture 1. The approximate installation of the oil pressure hoses, pipes and the bracket for the steel pipe.

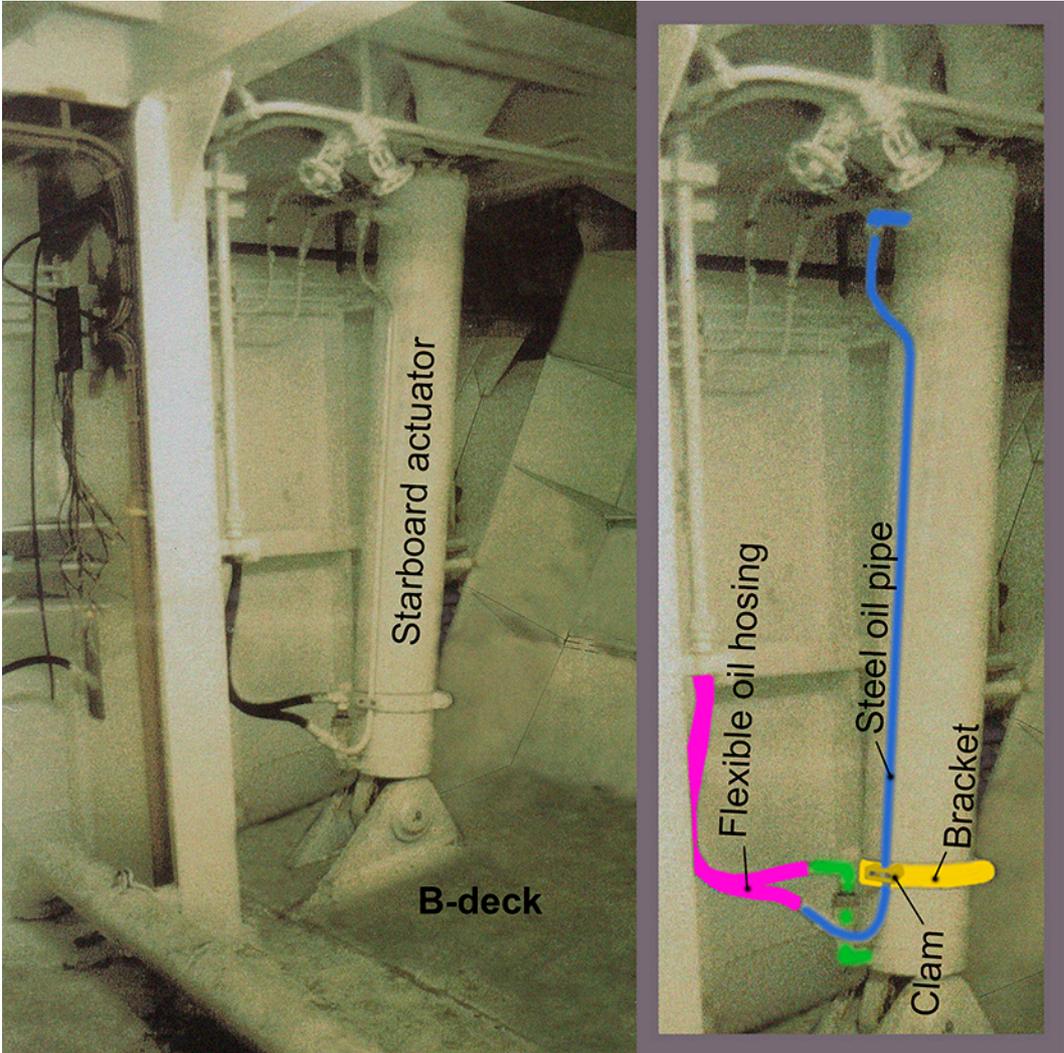
The arrangement was made to enable the two flexible hoses to be attached in the lower end of the actuator even though the outlet of the return oil was in the upper end of the actuator. From the upper end on the actuator a fixed steel pipe provided the return oil to flow in the system. In picture 3 and 4 below the detailed construction is shown.

Picture 3. The starboard actuator room. The hoses, steel pipe and bracket have been indicated with colored lines in reference to picture 1.

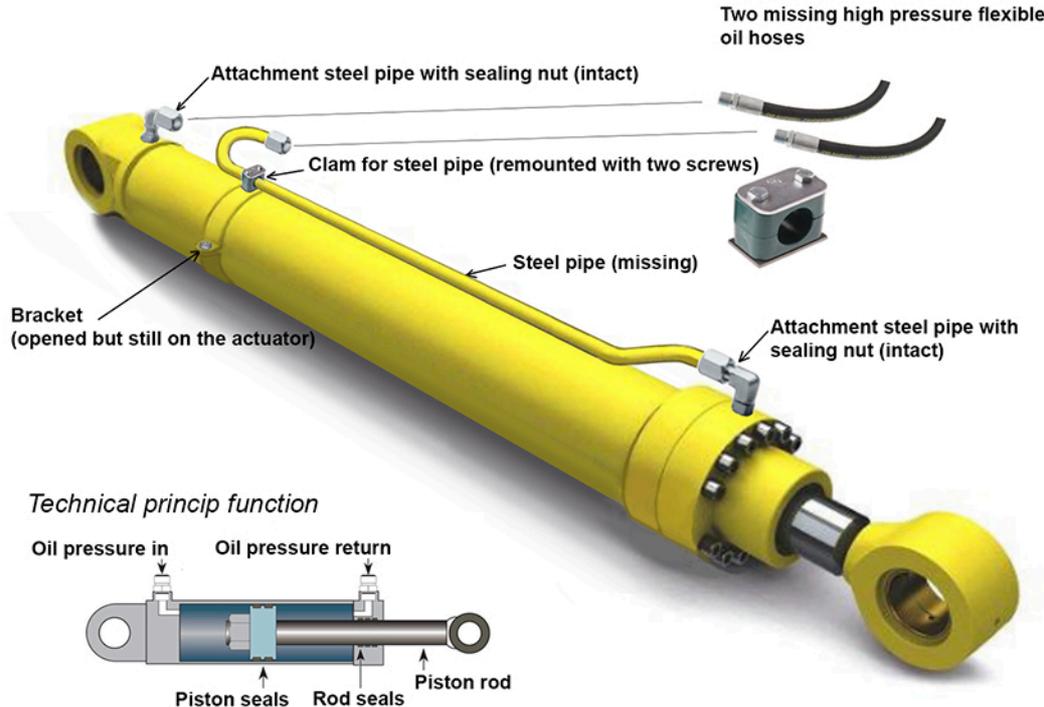
Picture 4. The arrangement shown as an example for explanation of the different parts of the hydraulic actuator and with comments in reference to this report.

The two actuators marked CD9-38725-6 250 were massive and each actuator had a maximum lifting/closing power at a design pressure of 250 bar of 153 ton. It is important to understand that a hydraulic actuator with an intact oil flow system is 100% stable, its piston rod cannot flex. This is due to the fact that oil can not be compressed. In any chosen position the actuator with its piston is to be seen as a fixed steel rod.

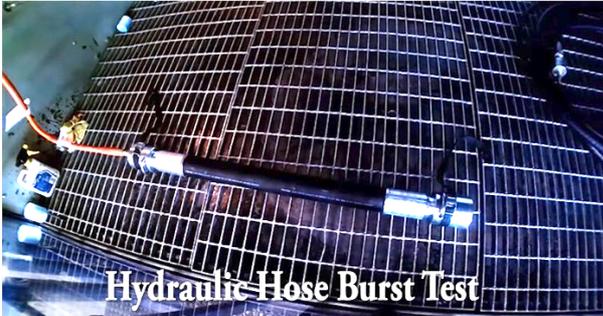
As both steel pipe and flexible hydraulic hoses are missing, is it also especially important to show what a flexible hydraulic hose looks like when it breaks due to overpressure or is ripped/pulled to breakage. The rating of the hose in this example is 420 bar and the burst occur at 1700 bar. If any of it had happened the remains of the flexible hoses had been found still attached to the actuators. This was not the case. **This is incontrovertible.**

Picture 9. High-pressure hydraulic hose set up.

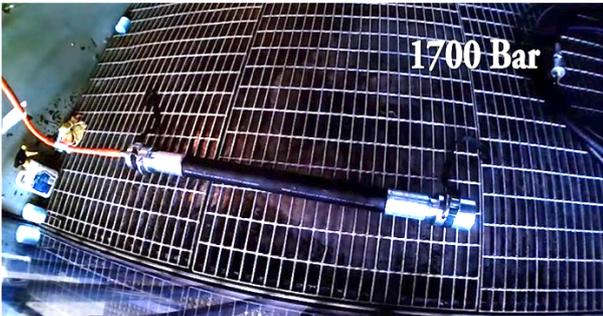
Picture 10. Pressure, 400% overload, rated 420 bar.

In picture 9 – 13 the result of a burst hydraulic flexible and high pressure hose is seen. As the hydraulic hose is weaker than the steel pipe it should have been ripped and broken similar to the burst of the hose in picture 13. Alternatively, the 90 degree attachment pipe made in steel with its attachment sealing nut had been broken due to the ripping effect. It was not.

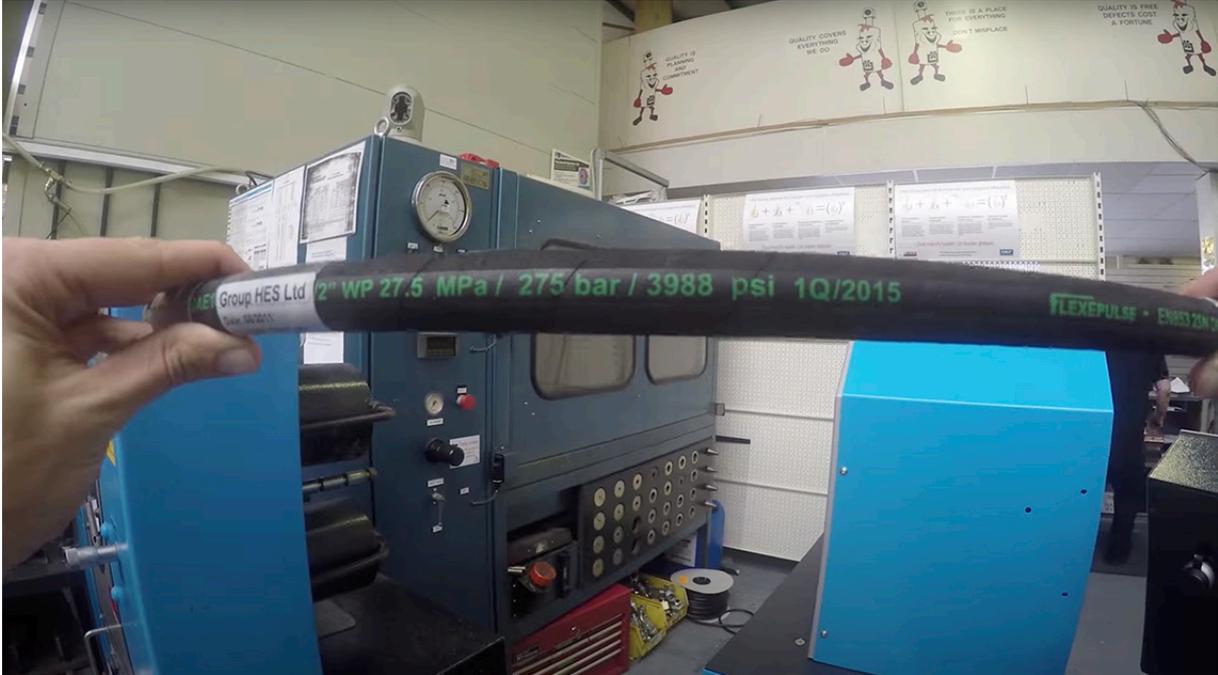
This test is conducted in a different way with the hose mounted in a way that can be seen as an example of a normal installation. The rating of the hose in this example is 275 bar and the burst occur at 1100 bar. This example gives a clear picture of the remains of the hose attached to the actuator.

Picture 14. The hydraulic hose rating, 275 bar.

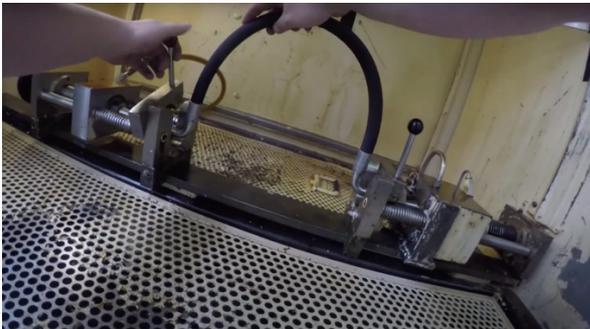
Picture 15. Setting up with two 90 degree steel hose attachments.

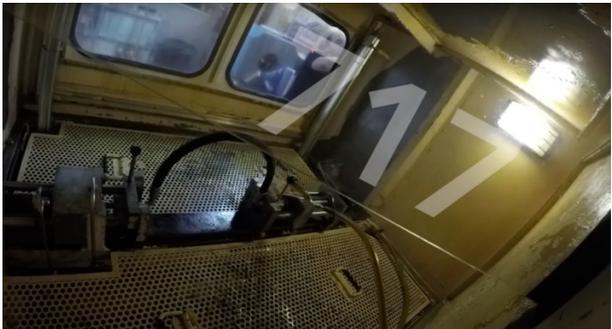
Picture 16. Test, 717 bar. Approx. 250 % overload.

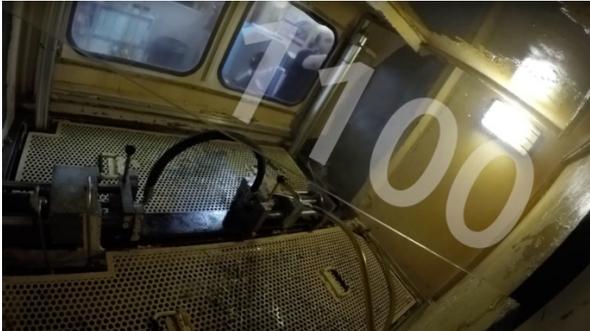
Picture 17 Test, 1100 bar. Approx. 400 % overload.

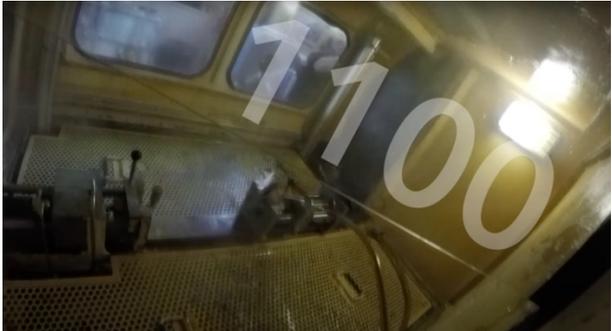
Picture 18. Test, burst at 1100 bar.

As the pressure needed to destroy the actuator seals must be at least 1400 bar we conclude that the flexible hosing's rated between 275 to 350 bar would have burst before the piston rod seals had been damaged. However, the flexible hoses and the steel pipe were missing and the screws in the bracket and clam were remounted, that is the crucial and incontrovertible key information in this report.
