**Subject:** Lies and truths about the salvage of MV Estonia's MOB rescue boat, and further on, The Independent Factgroup present their final investigation report regarding the MOB boat.

**Type:** Analysis  
**By:** The Independent Fact Group  
[www.factgroup.uk](http://www.factgroup.uk)

**Status:** Proved  
**Date:** 2022-04-11  
**Version:** Report-English

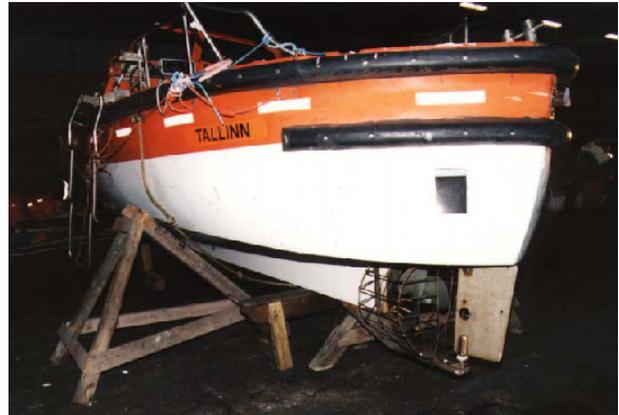
*National Bureau of Investigation picture # 2*

*The propeller shaft is intact and the propeller revolves freely, picture # 2.*

Moreover, according to NBI, the MOB boat was in good condition without hull damage. The propeller shaft was intact, as was the propeller that could rotate. The gear was neutral, and the speed lever was idle.

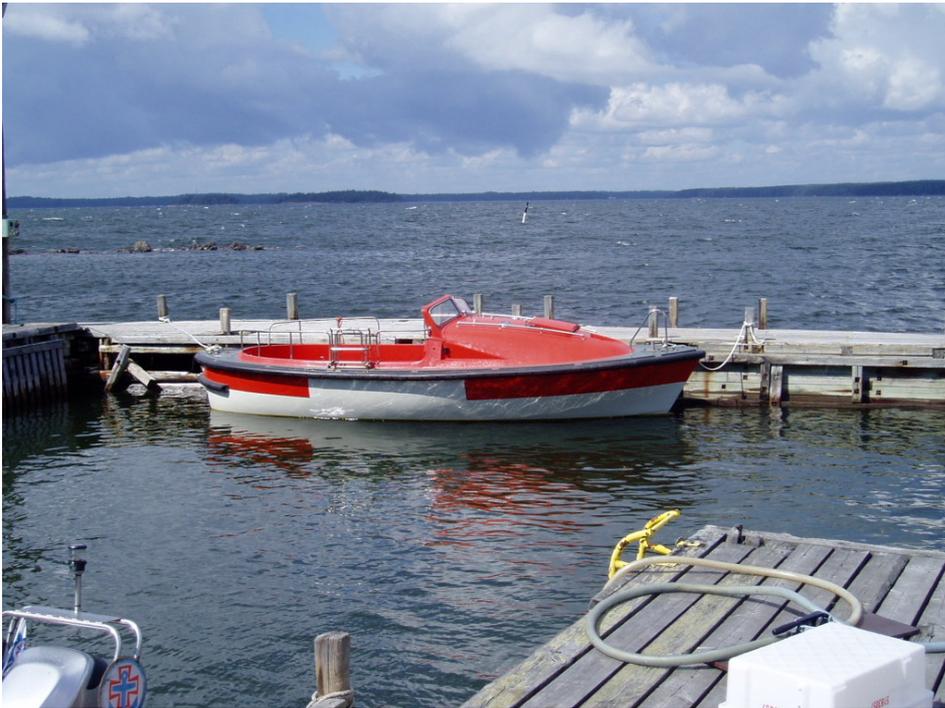
Picture 6. *The MOB boat after renovation in Boistö harbor. Photo: Lars Andersson.*

There was a lot of fiberglass work done, and a new engine (Caterpillar 86 hp) was installed as new steering with rudder shaft. Finally, the boat was ready for the 2002 season at the Finnish Sea Rescue Association's training center at Boistö, where it came to be used very little.

The boat was renovated to top condition, and new equipment for navigation and safety was installed. In addition, the newly installed engine contributed to a safer life rescue boat.

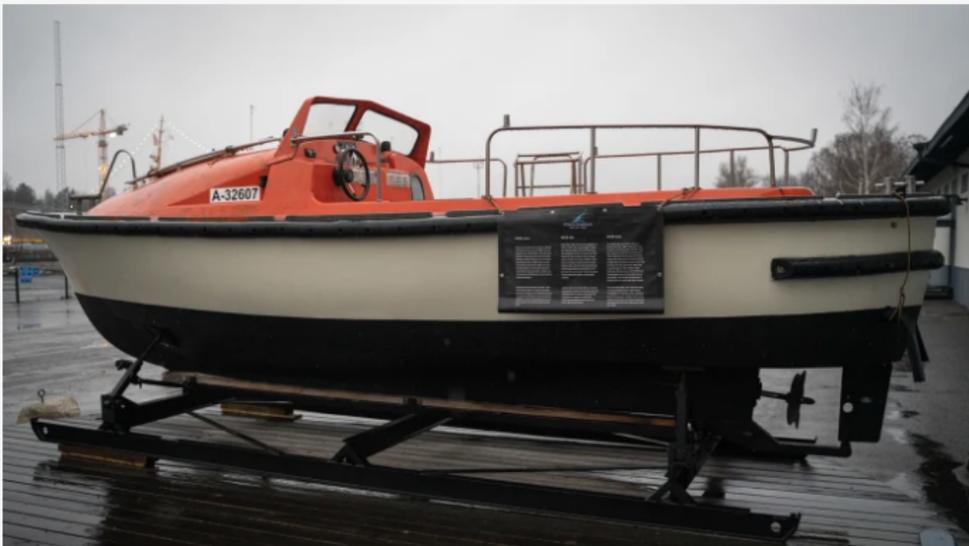
"Jag har aldrig hört talas om detta. Men jag inspekterade MOB-båten själv och jag kan intyga att den inte såg ut att ha använts", skriver Tuomo Karppinen.

Mytomspunnen MOB-båt från Estonia står utanför Forum Marinum i Åbo. Bild: Yle/Taisto Lapila

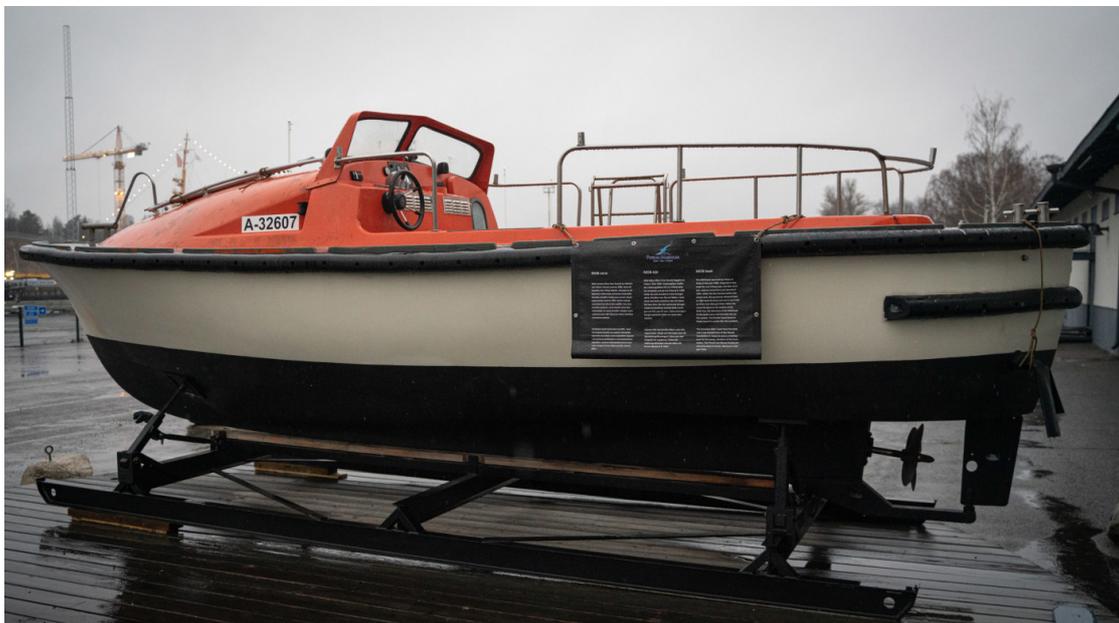
"I have never heard of this. But I inspected the MOB boat myself and I can certify that it did not appear to have been used," writes Tuomo Karppinen.

Mythical MOB boat from Estonia stands outside Forum Marinum in Turku. Photo: Yle / Taisto Lapila
