The Independent Fact Group

Subject: MV Estonia shipwreck scenario

Type: Report

Date: 2022-11-10

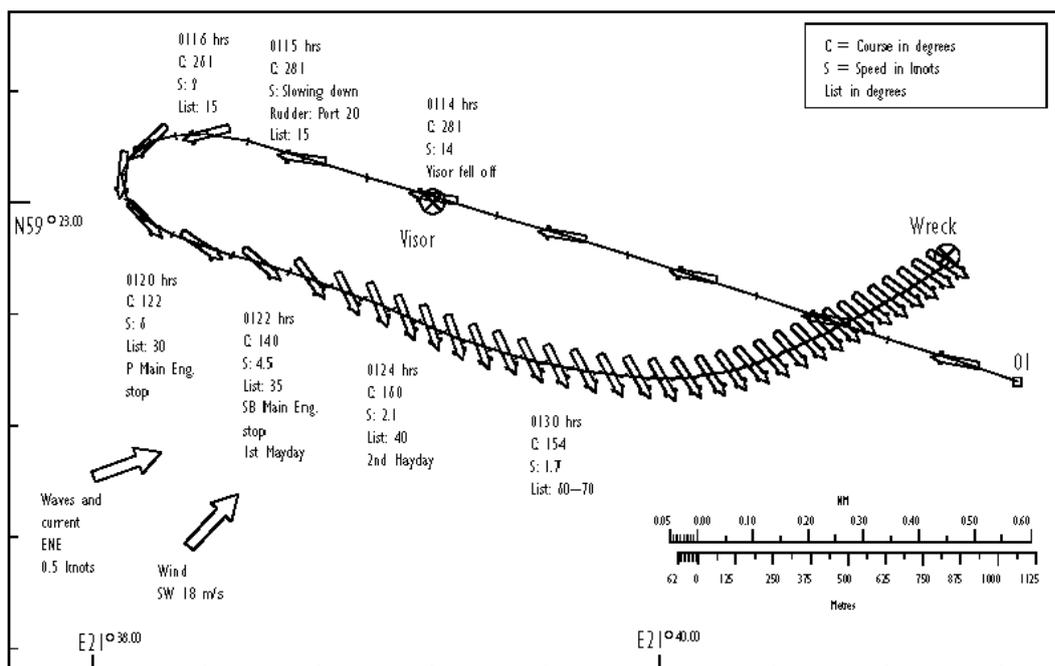
- JAIC Final report 13.12, navigation simulator at the Maritime Academy in Kalmar,

JAIC presents three drifting scenarios based on computer analyses, and none correspond to the facts or actual conditions of the wind, waves, and currents.
