Subject: The visor floatability and impossible sinking scenario

Type: Analysis

By: The Independent Fact Group
www.factgroup.uk

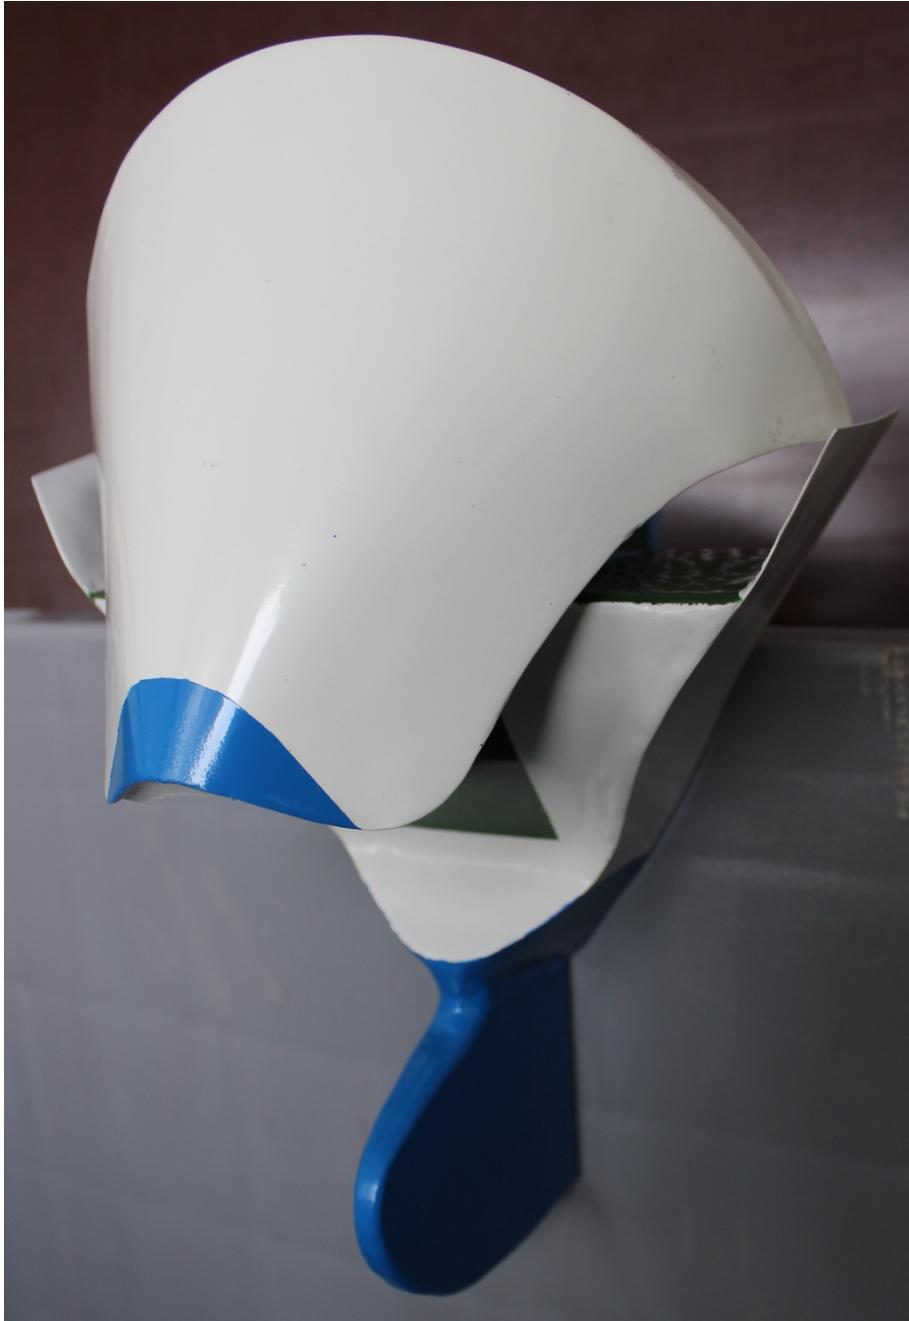
Picture 8. Building the visor model, prepared for first test in tank.

In a possible floating position, the visor must displace its weight, 64 m³ of water, which corresponds to the weight of the visor (64 metric tons) when measured after the salvage. The total volume of the visor, which only theoretically could contribute to flowability, has been measured at approx. 130 m³.

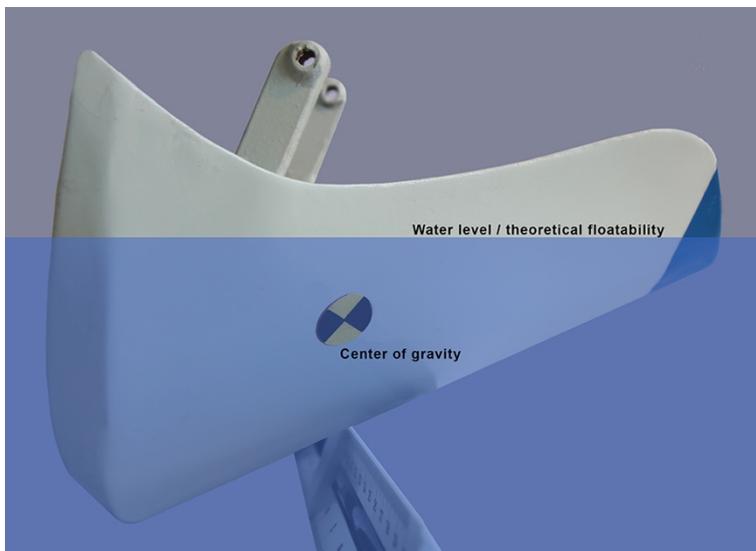
Picture 9. Visor balance and water level in still water and perfect circumstances.

We adjusted the weight of the visor model to result in a theoretical floating position that corresponded to the actual visor.

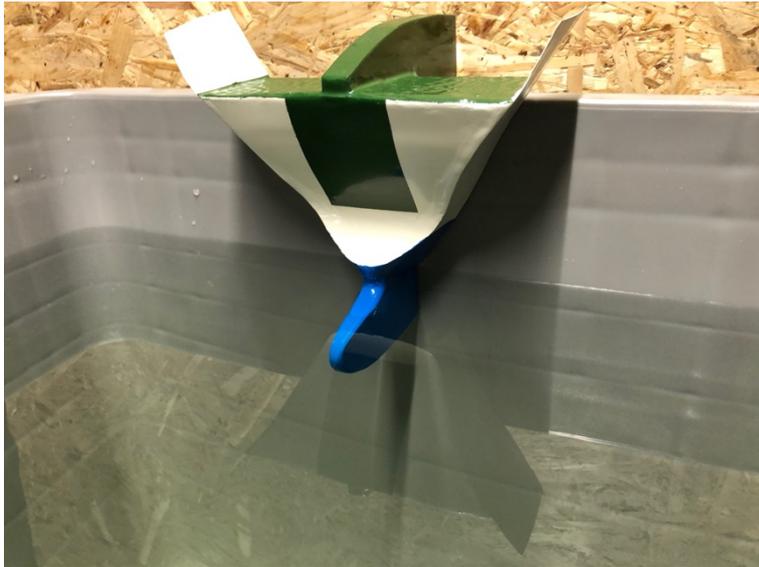
Picture 10. The model of the forward bulkhead ready for testing.

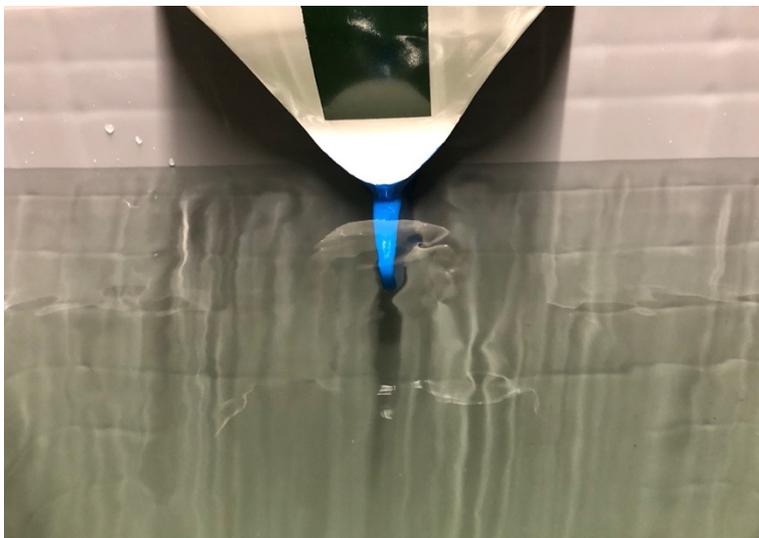
Picture 11. The model of the forward bulkhead in water with the water level adjusted.

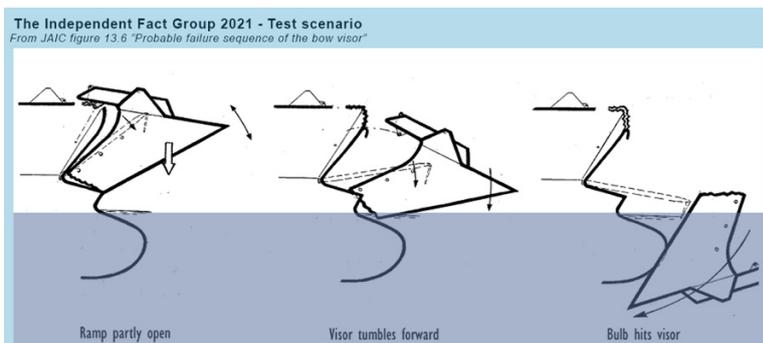
We let the visor fall off in a forward direction, described in the JAIC report Figure 13.6 "Probable failure sequence of the bow visor." Our test scenario starts at "Ramp partly open" to "Bulb hits visor."

Picture 12. The test scenario.

We did not include the ramp in the model test because it did not influence the scenario when the visor fell off after all the locks and hinges had broken, according to JAIC.

Our model was built undamaged in the bottom structure. Therefore, if the visor fell off during the shipwreck and hit the water, the damage heavily should have reduced its floating capacity.
